# 4 Semestral Report  
June 2024

## Pakistan: Balochistan Water Resources Development Sector Project

# Semi – Annual Environmental Monitoring Report

July - December 2023

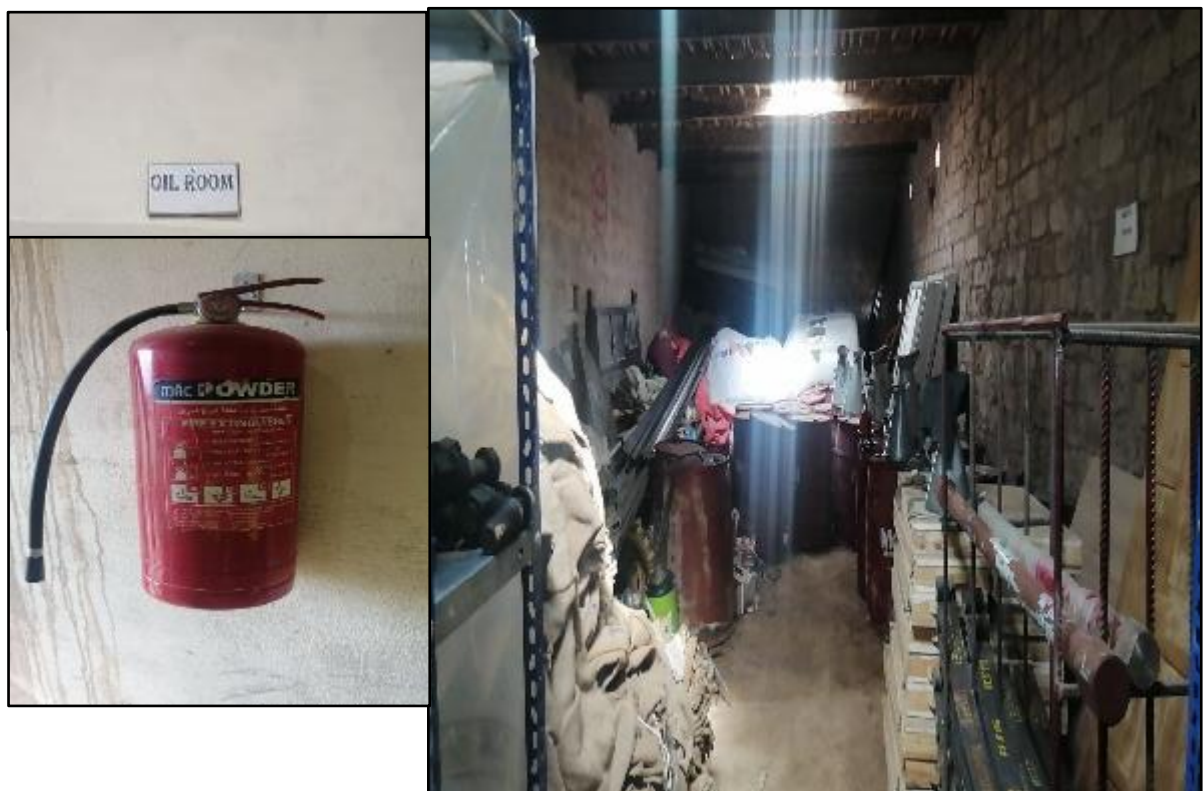
- **Oil Room**

36. Oil spillage was observed causing soil contamination (At diesel store site and near generator placement) and, Snacks were found in the oil room. Various non-compliances were observed during the field visit by the monitoring consultant, which signifies that ample supervision is not being carried out by the consultants.
37. As per Consultant's statement, some non-conformances were observed under Sub-Project ICB-01, and considering the contractor's lack of experience in environmental management, it took several months period for the Contractor of ICB 01 to understand, prepare and submit SSEMP.
