Semi-annual Environmental Monitoring Report

Project Number: 48098-002

January-June 2025

## Islamic Republic of Pakistan: Balochistan Water Resources Development Sector Project

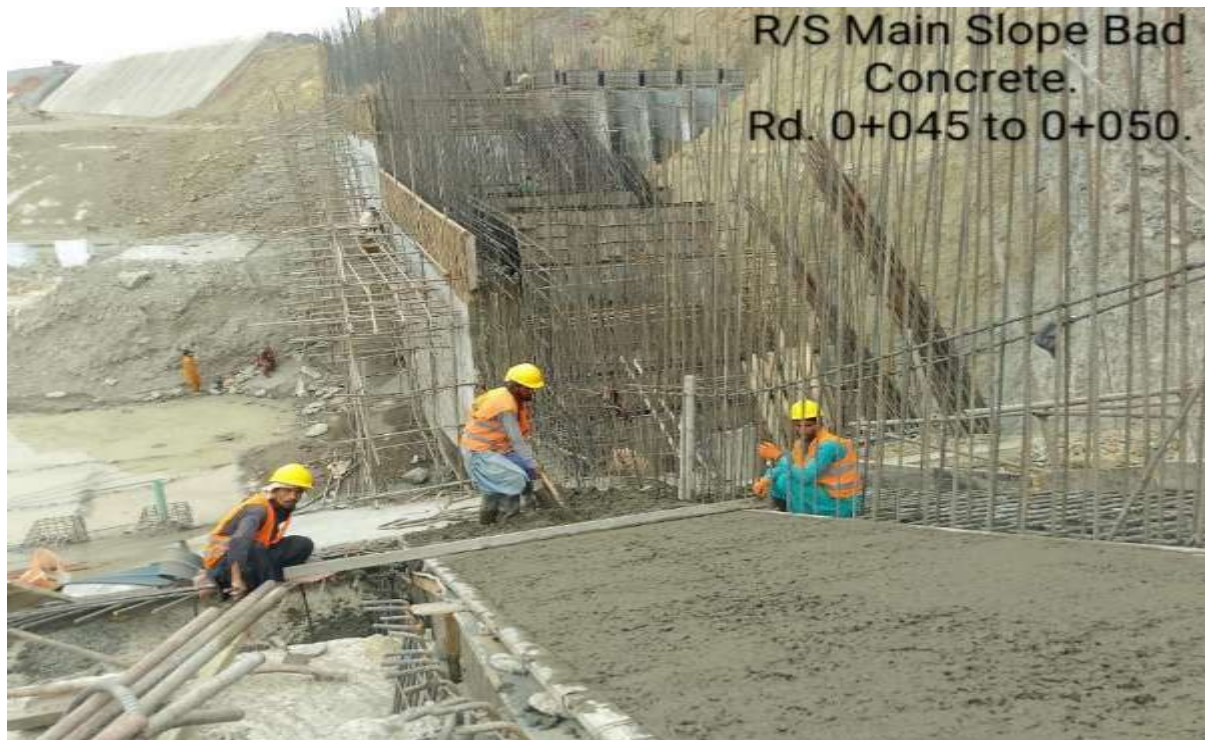
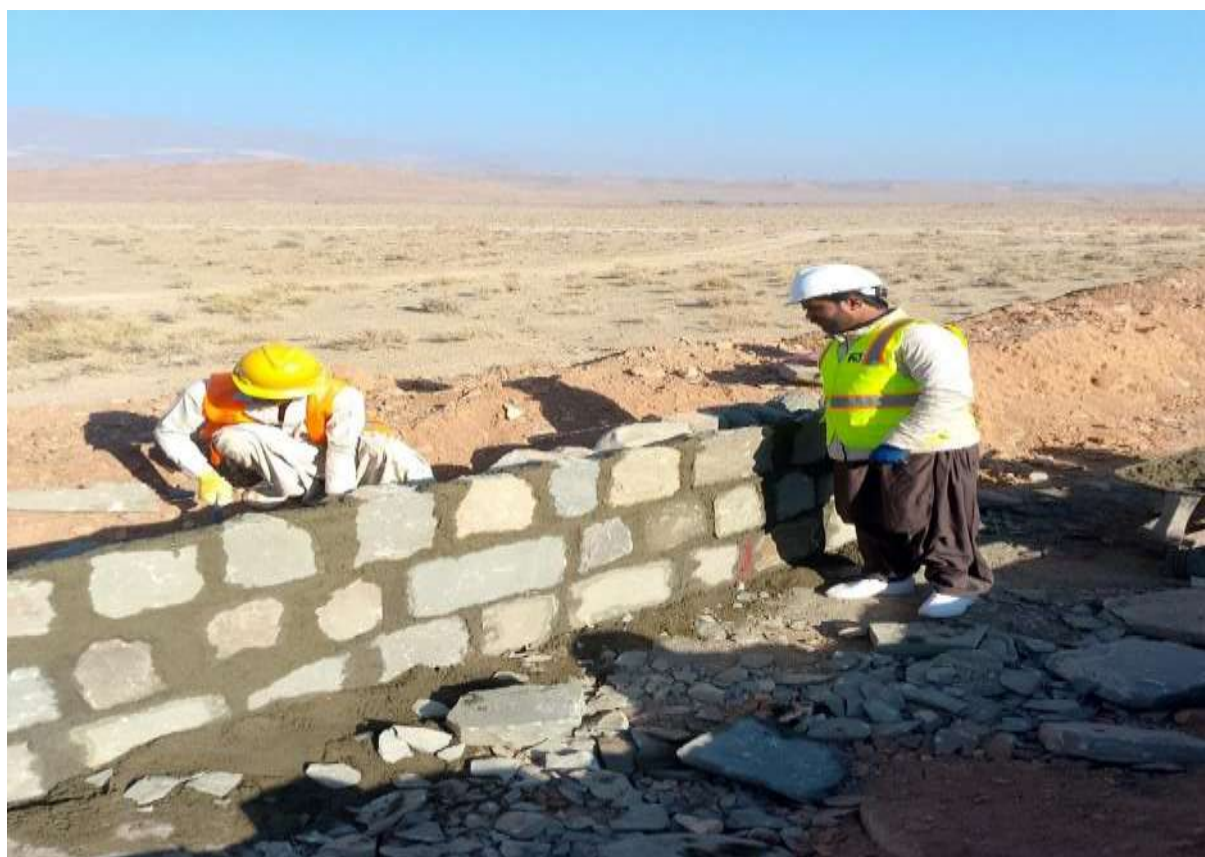
Figure 3-2: Works Progress in Pictures

42. The construction activities at various sections of Site are in progress in accordance with the Engineer's approved methodology and specifications.

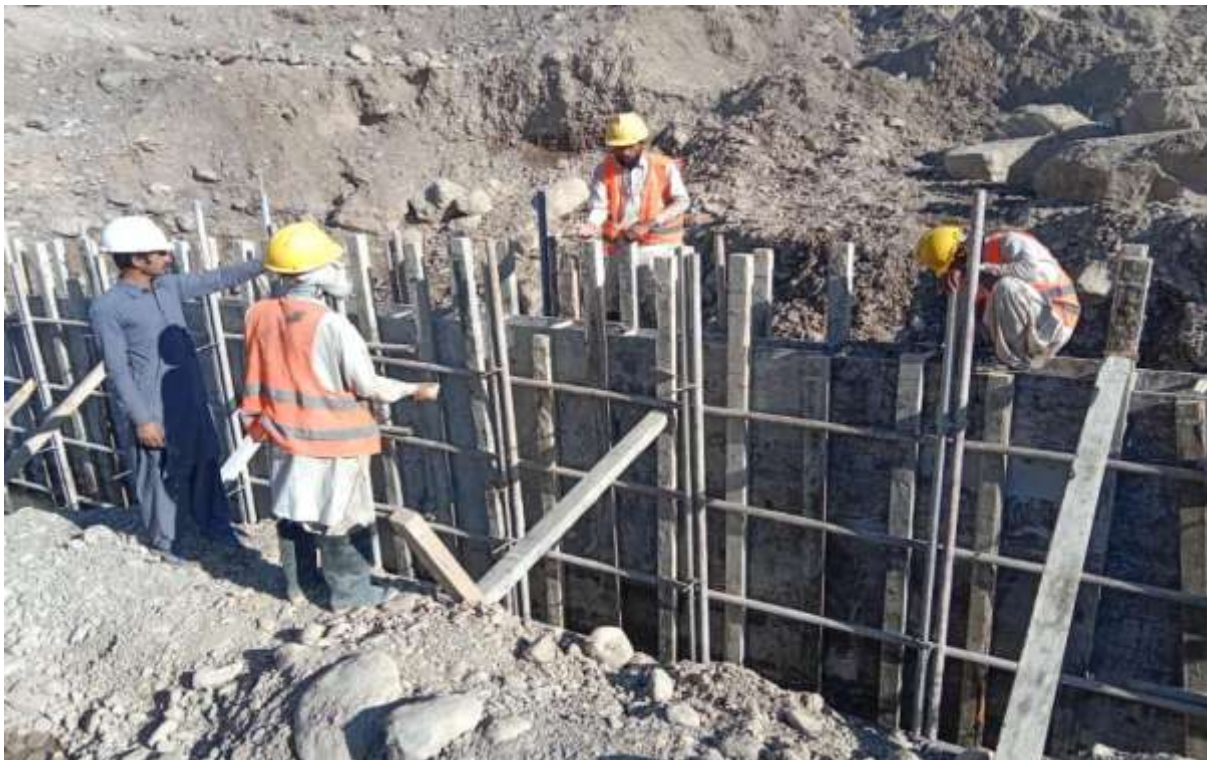
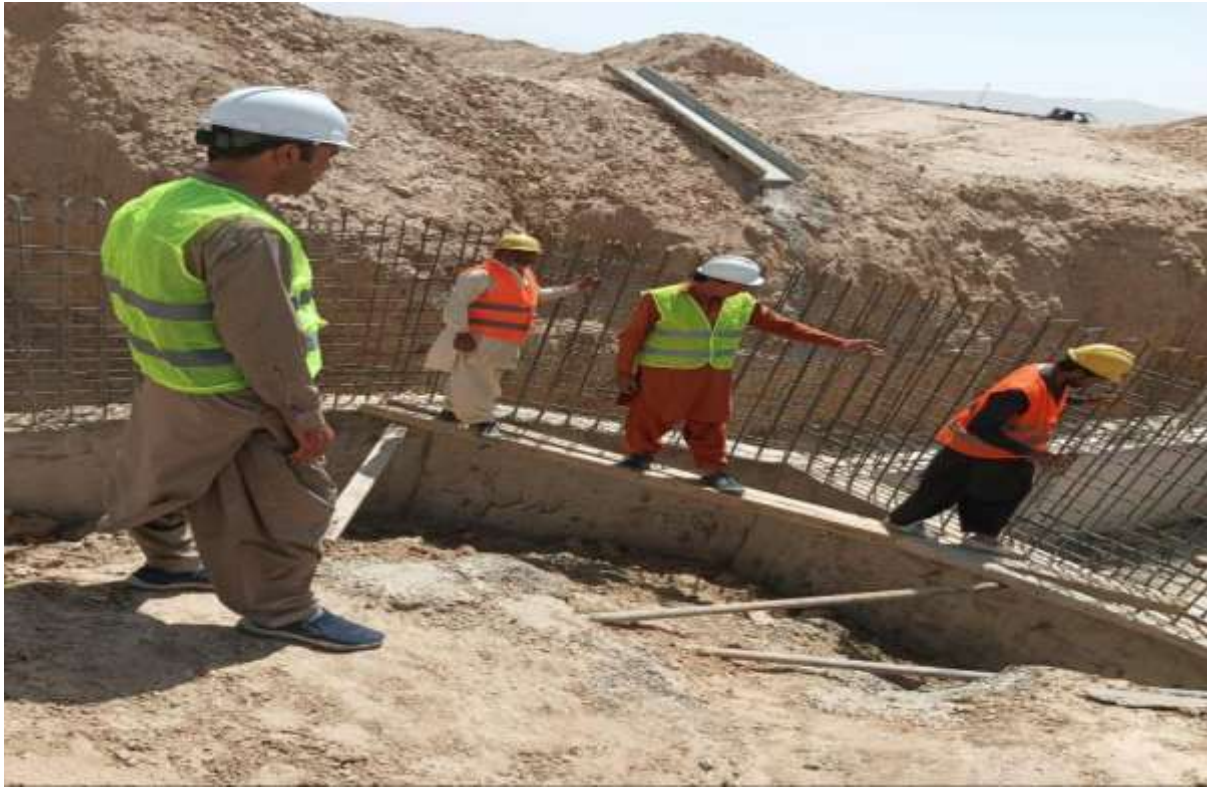
**Figure 4-2: Construction of Pashta Kha D/S Weir Panel No .5 in Progress**

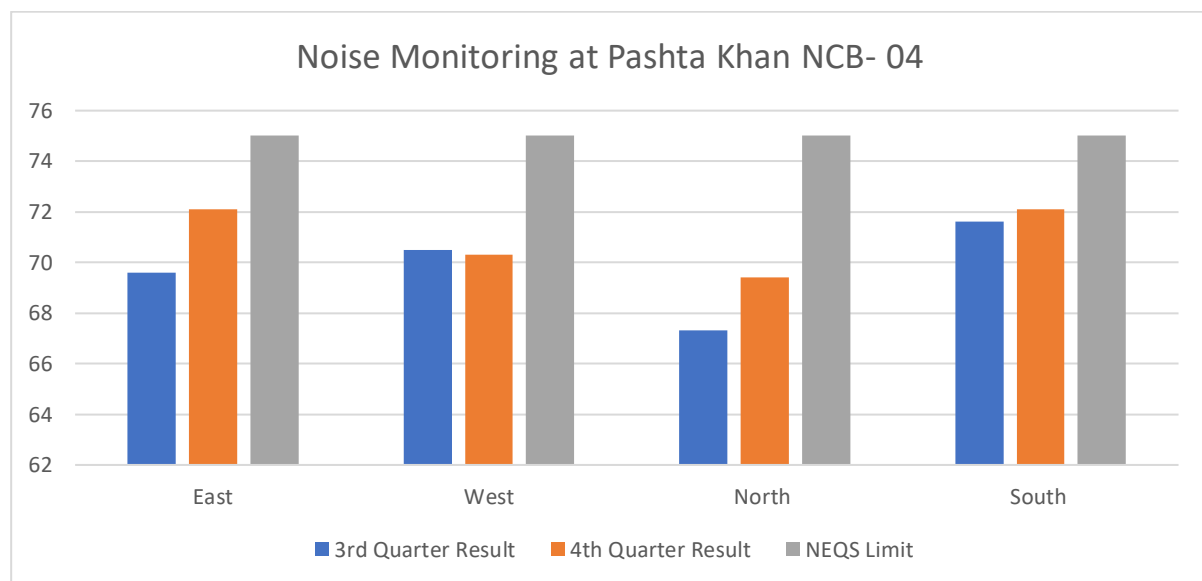
Figure 4-4: Graphical representation of Noise Monitoring at NCB-04

130. The following table 6-8 shows comparison of noise level monitoring results obtained during the instrumental monitoring.

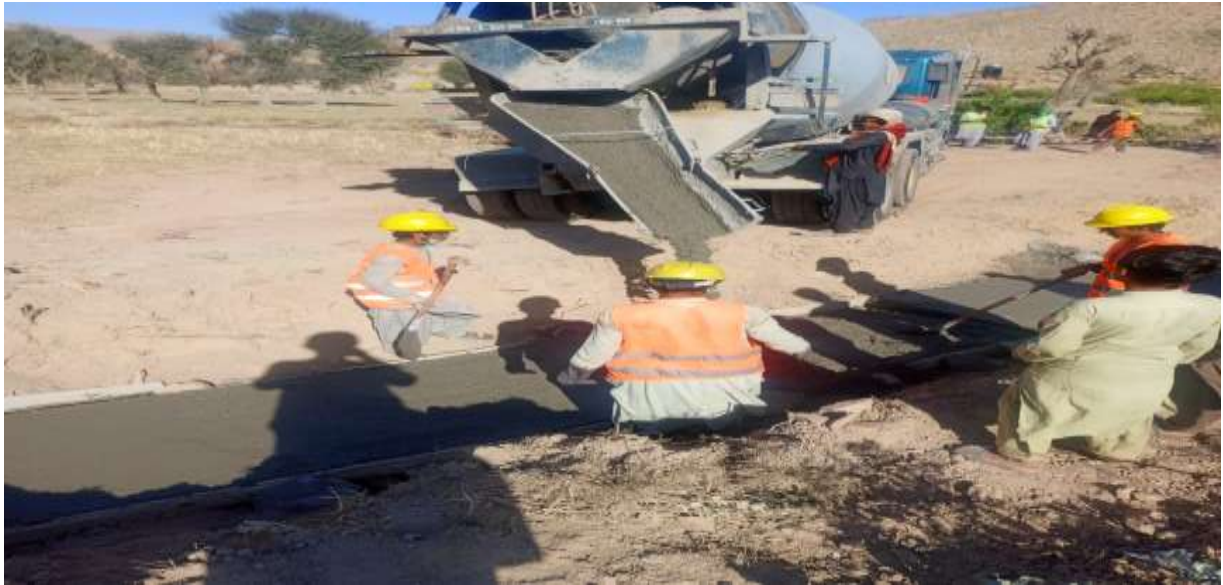
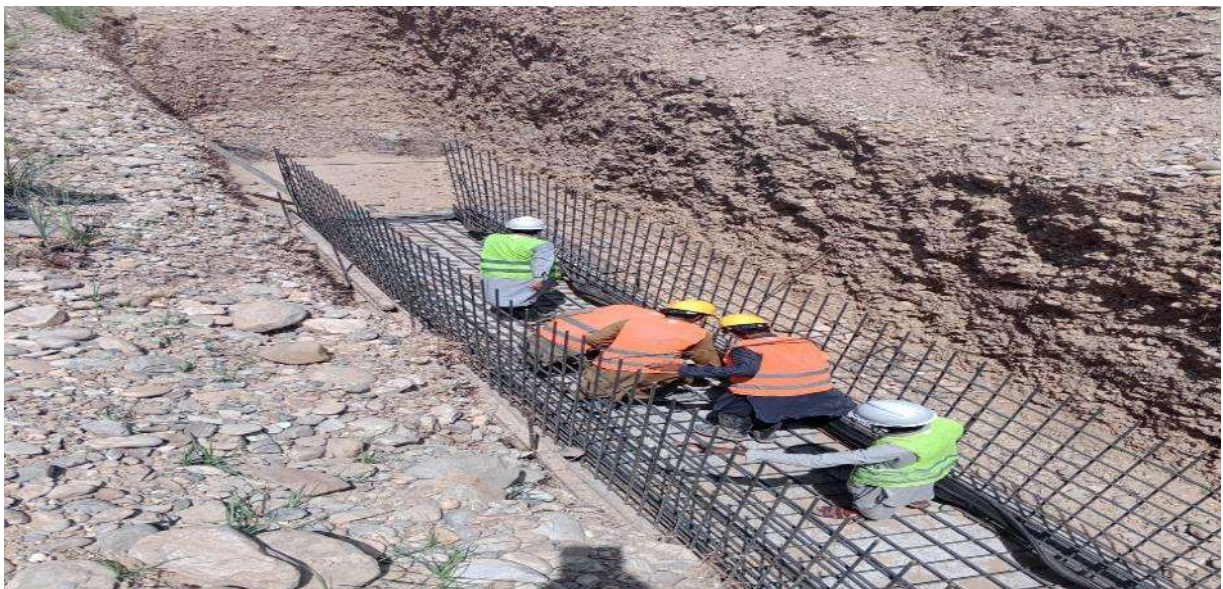
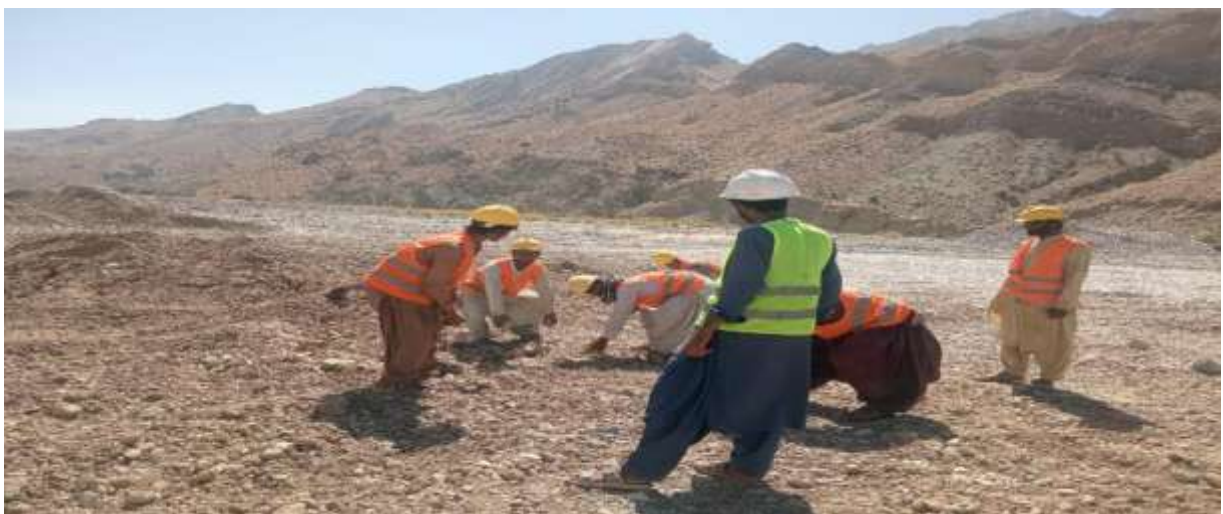
**Figure 5-2: On going Construction activities at NCB-07**

158. The construction activities at various sections of Site are in progress in accordance with the Engineer's approved methodology and specifications

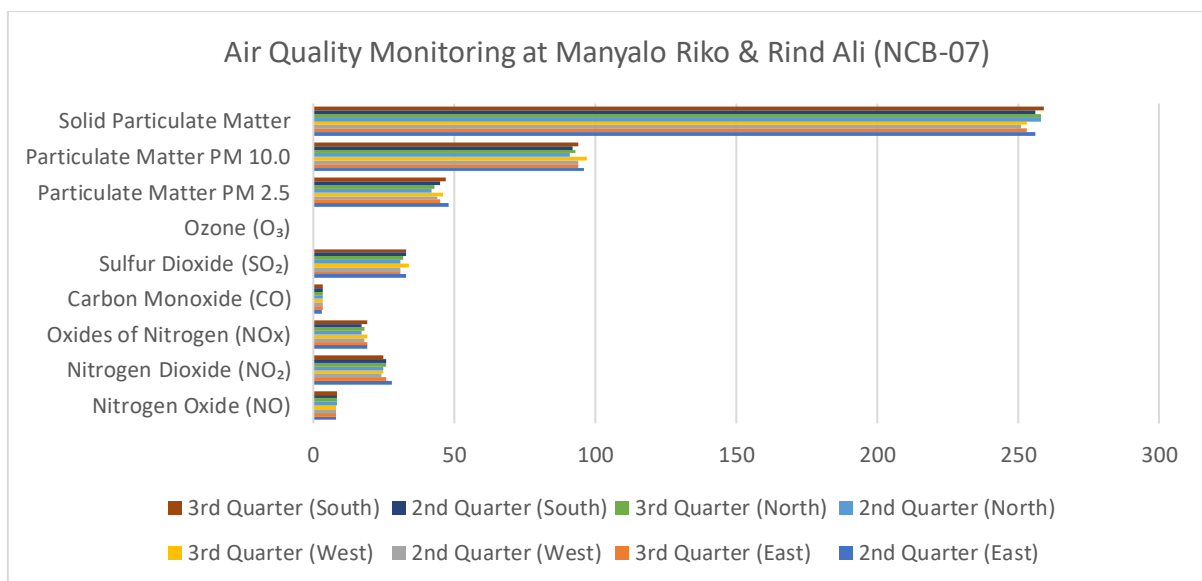
**Figure 5-3: Graphical representation of Ambient Air Quality at NCB-07**

174. The contractor has performed quarterly monitoring at the sub-project sites and all the results are within the permissible limits and compliance with the BEQS, NEQS and WHO standards. are shown as in Figure 4-3 and Table 5-7. Signed copies of the results are attached as **Annexure-VI**.

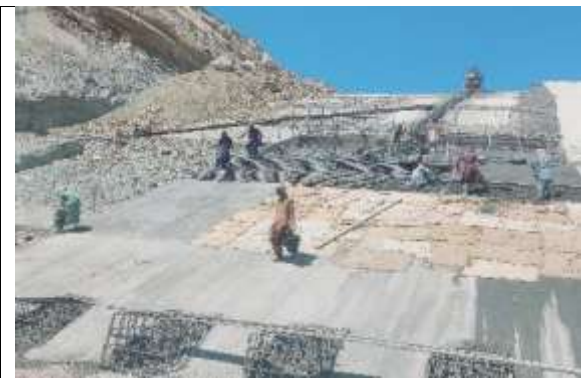
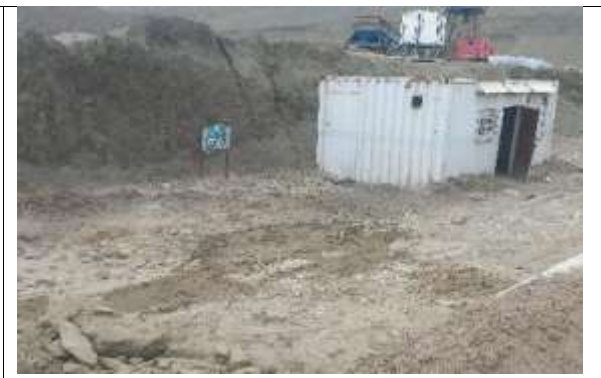
**Sliding will be harmful for the workers**

**Poor housekeeping observed at the dam site area, with uneven ground conditions noted throughout the location**

57. In light of the above observations, the Contractor was formally instructed to undertake immediate corrective actions, including strict enforcement of PPE usage, installation of proper safety signboards and barricades, strengthening of dust control and waste management measures, and restoration of safe ground conditions. The matter has been categorized as high priority, and the Contractor has been directed to ensure full compliance with EHS obligations to mitigate risks to personnel and the surrounding environment.

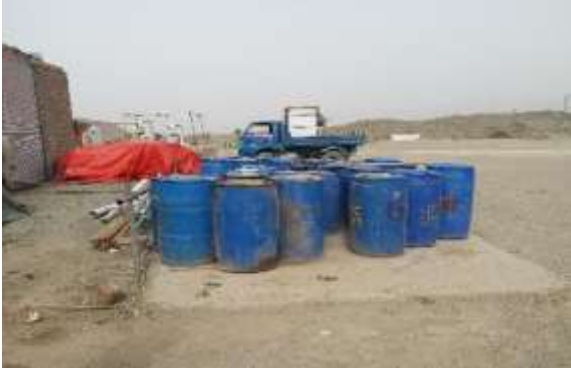
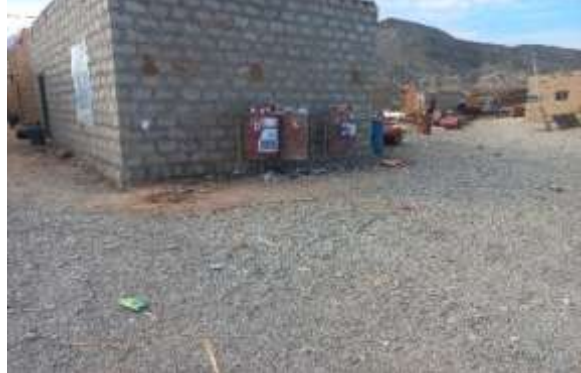
<p><b>Improper handling and storage of chemical drums observed, with direct exposure to sunlight.</b></p>	<p><b>Didn't dispose off the waste</b></p>

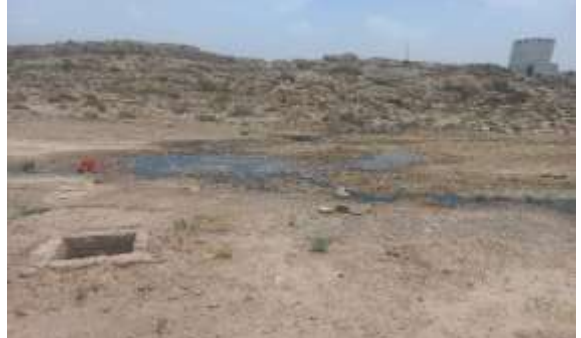
<p><b>visible environmental contamination, likely due to improper sewage or wastewater discharge</b></p>

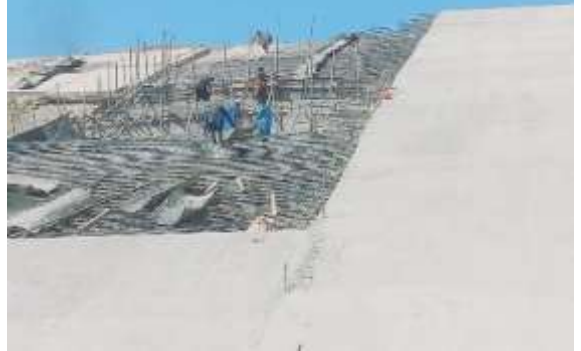
<p><b>Non-compliance with scaffolding safety protocols detected</b></p>	<p><b>Non-compliance with fall protection protocols</b></p>

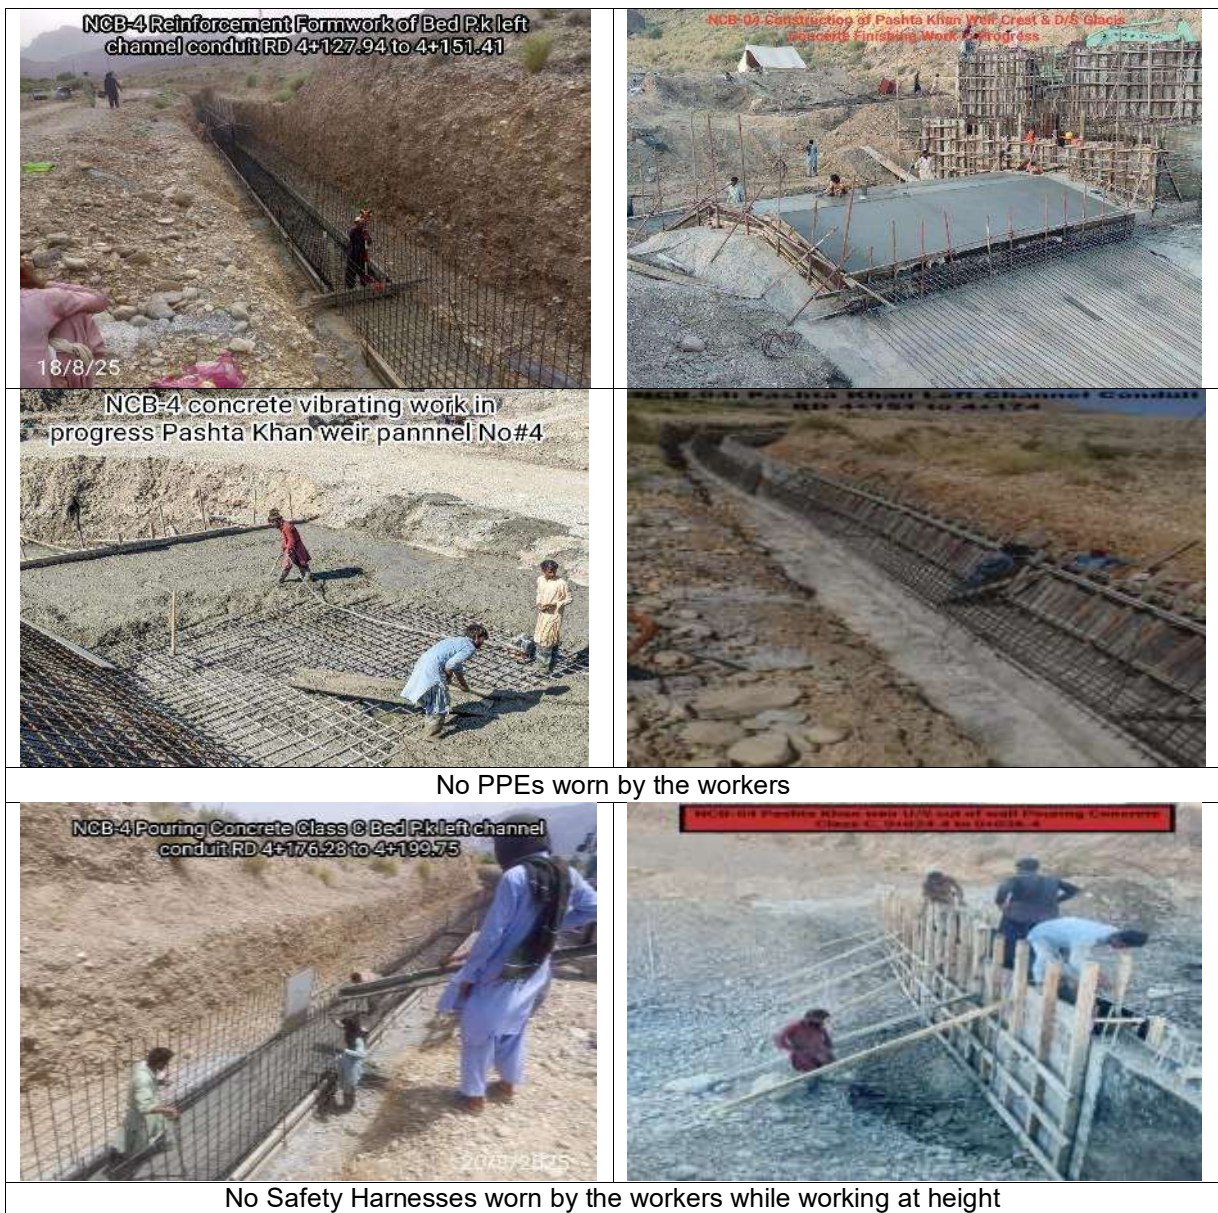
No Safety Signboards installed at site

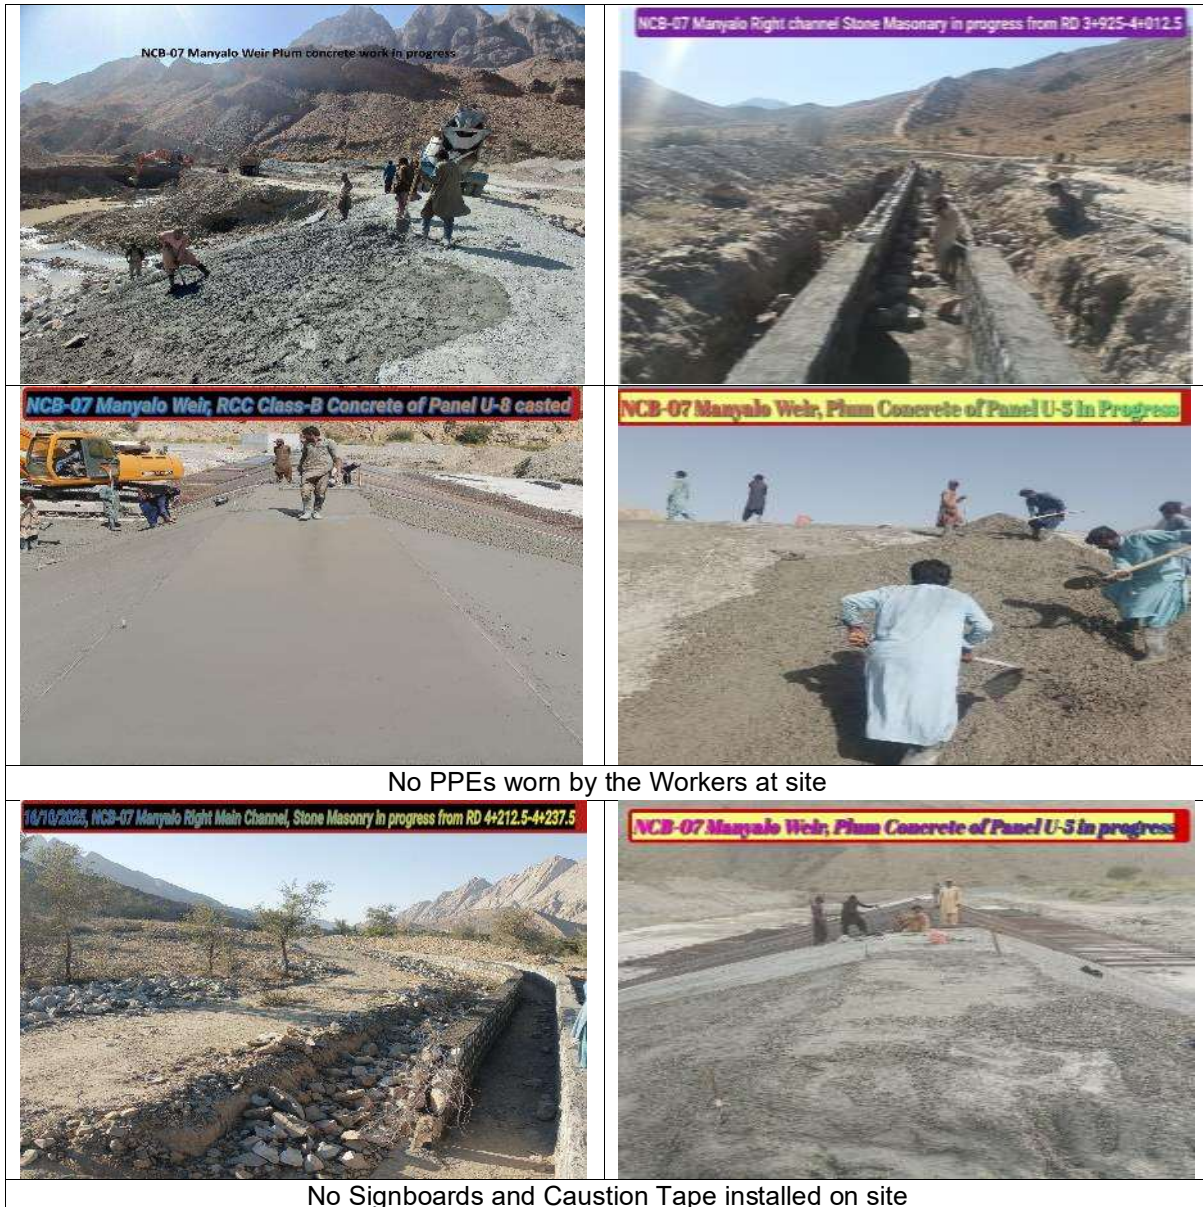
No PPEs worn by the Workers at site

No Signboards and Caution Tape installed on site
