Environmental Monitoring Report

8 Semestral Report
May 2025

Pakistan: Balochistan Water Resources Development Sector Project

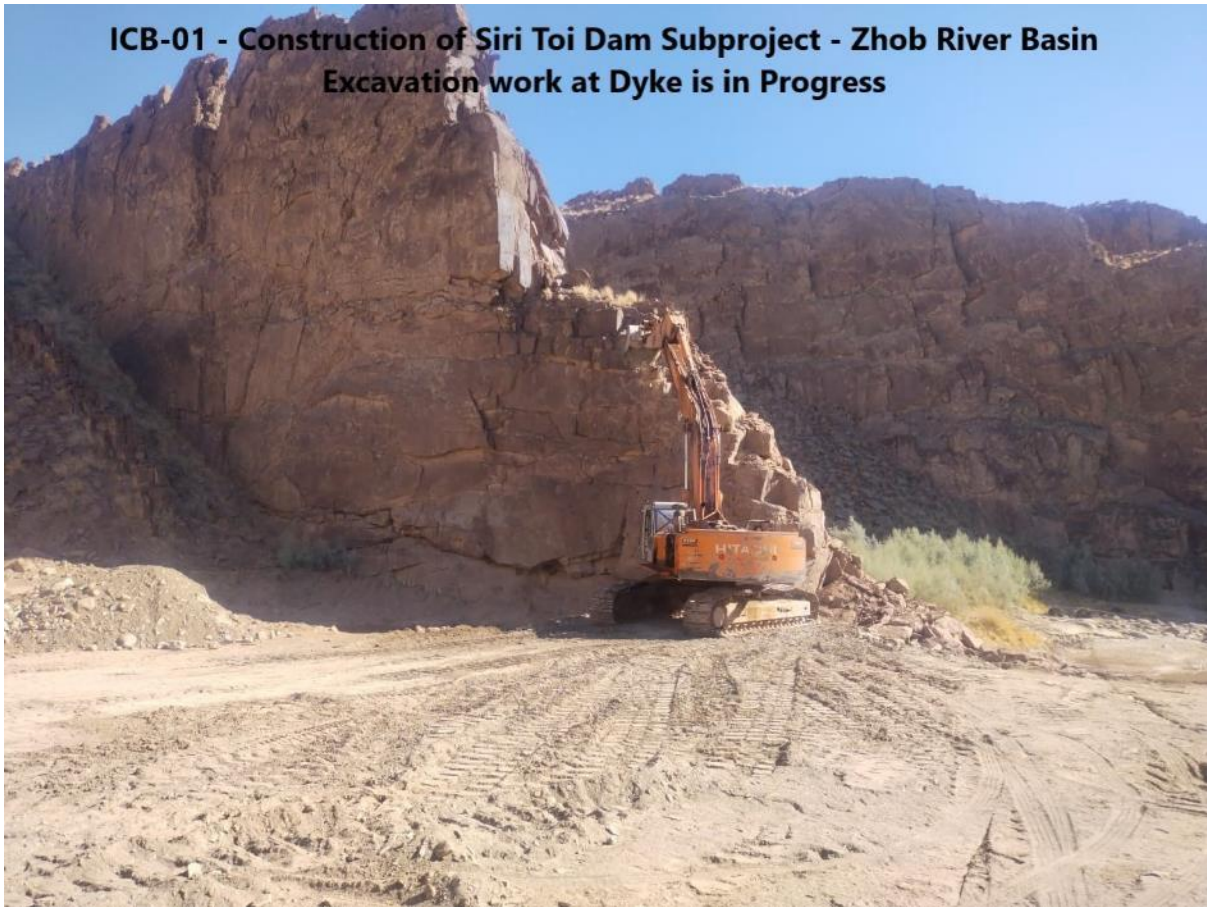
**ICB-01 - Construction of Siri Toi Dam Subproject - Zhob River Basin
Excavation work at Dyke is in Progress**

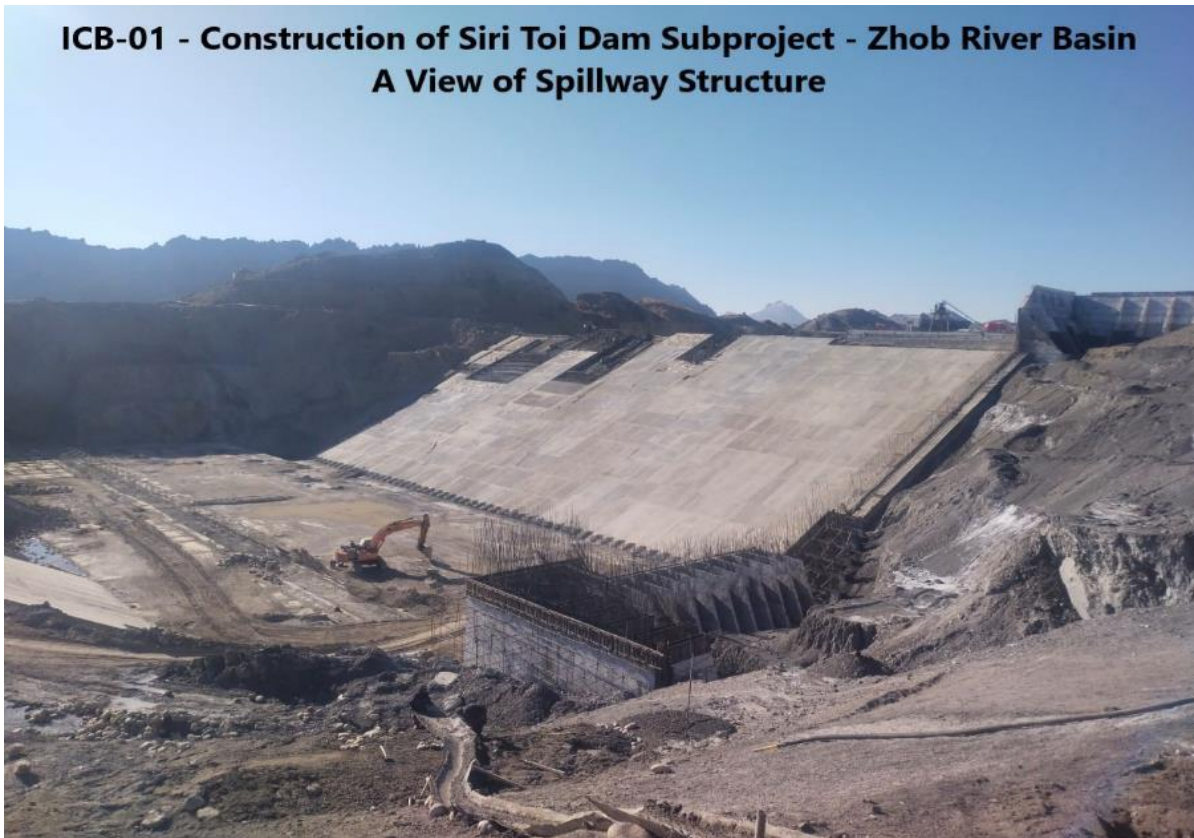
**ICB-01 - Construction of Siri Toi Dam Subproject - Zhob River Basin
A View of Spillway Structure**

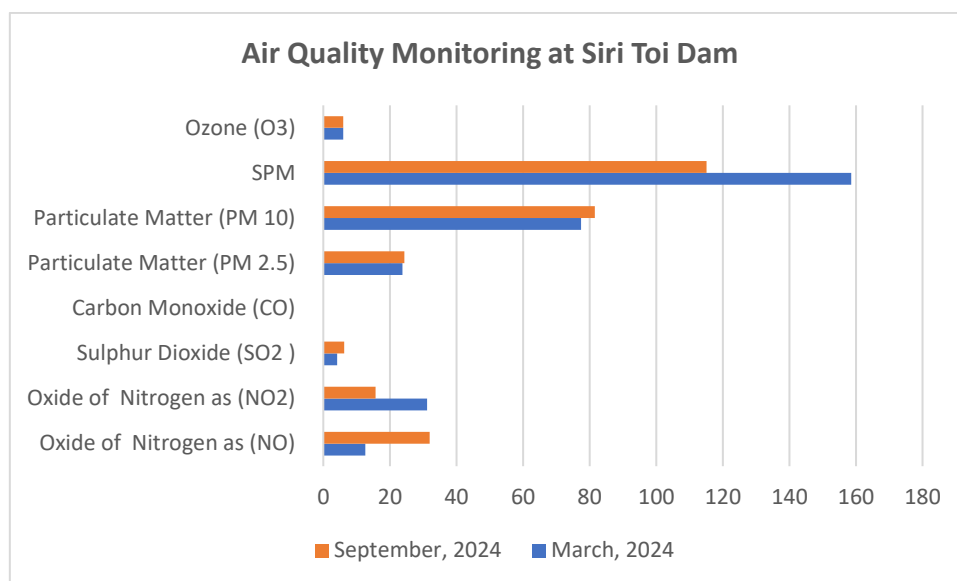
Figure 3-2: Air Quality Monitoring at Siri Toi Dam Camp site

69. Ambient air quality (NO, NO₂, SO₂, CO, O₃, SPM, PM₁₀, PM_{2.5}, Humidity, Wind direction, Wind velocity, Pressure etc) were monitored for twenty-four (24) hours at the locations identified by the SC and results obtained are shown in graphical representation.

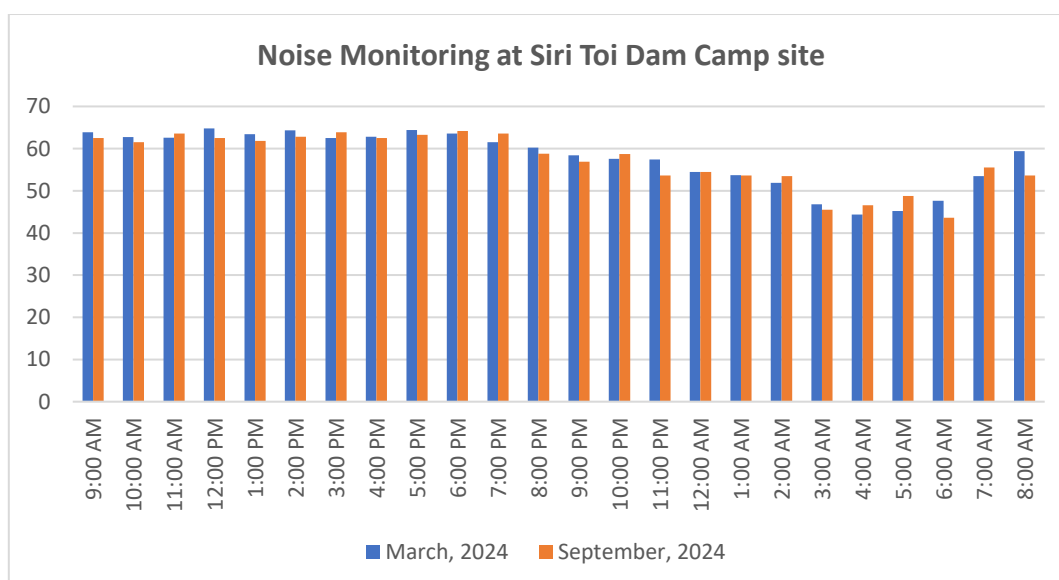
Figure 3-3: Noise Monitoring at Siri Toi Dam Camp site

74. The comparison of noise level monitoring results obtained during the monitoring period is shown in Figure 3-3 and Table 3-10.

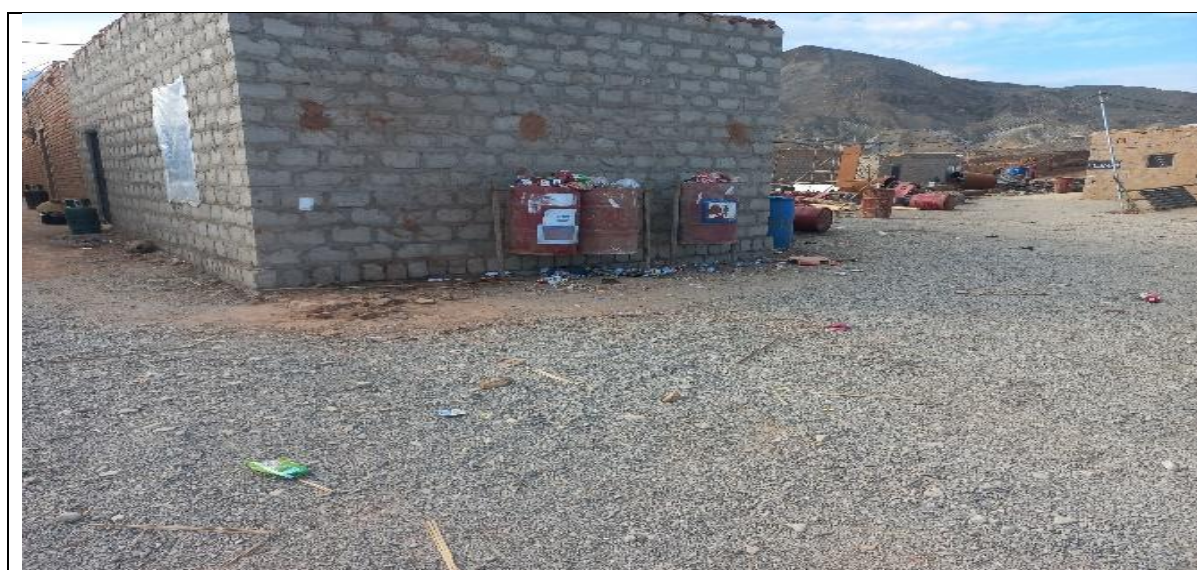
Figure 3-4: Waste segregation

Solid Waste overflowing bins in Siri Toi Dam Camp site

85. The contractor has provided waste collection bins at various points in the camp and work sites. Consequently, waste is being collected in these bins; however, solid waste has not been disposed off, resulting in overflowing bins. Lack of housekeeping has been observed at the dam site, and the ground has been found to be uneven. Construction wastes, such as plastics and paper, are collected and transported to the designated waste receiving area within the camp.

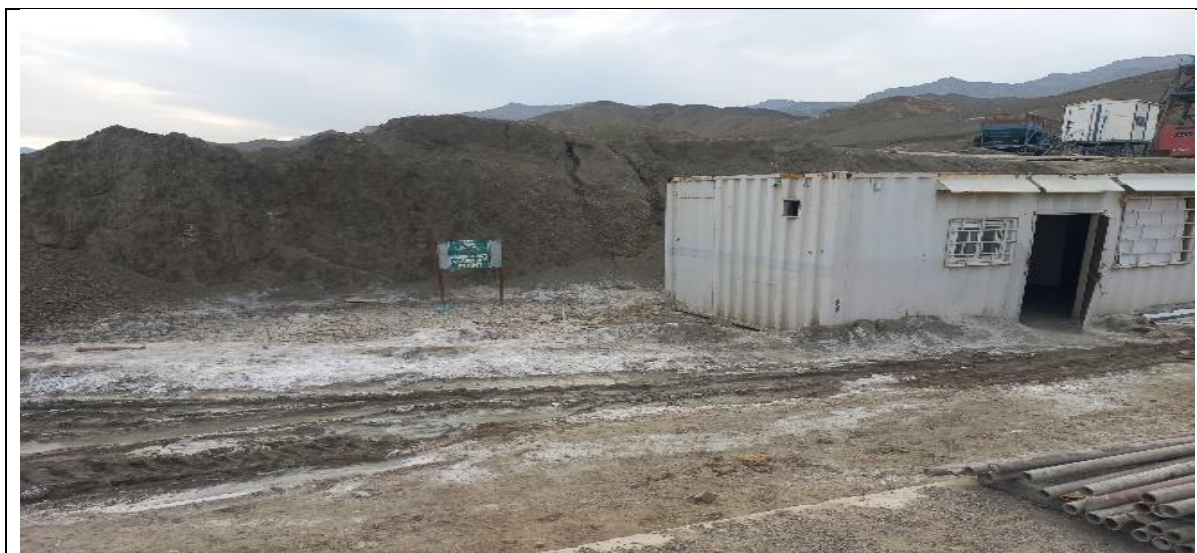
Lack of housekeeping on the dam site area, and the ground is observed uneven

51. During site inspections, several safety issues were identified, including sliding hazards due to uneven ground and inadequate housekeeping at the dam site area. The Contractor was instructed to level the ground, improve housekeeping, and implement safety measures. Additionally, waste disposal at the Assembly Point was improperly

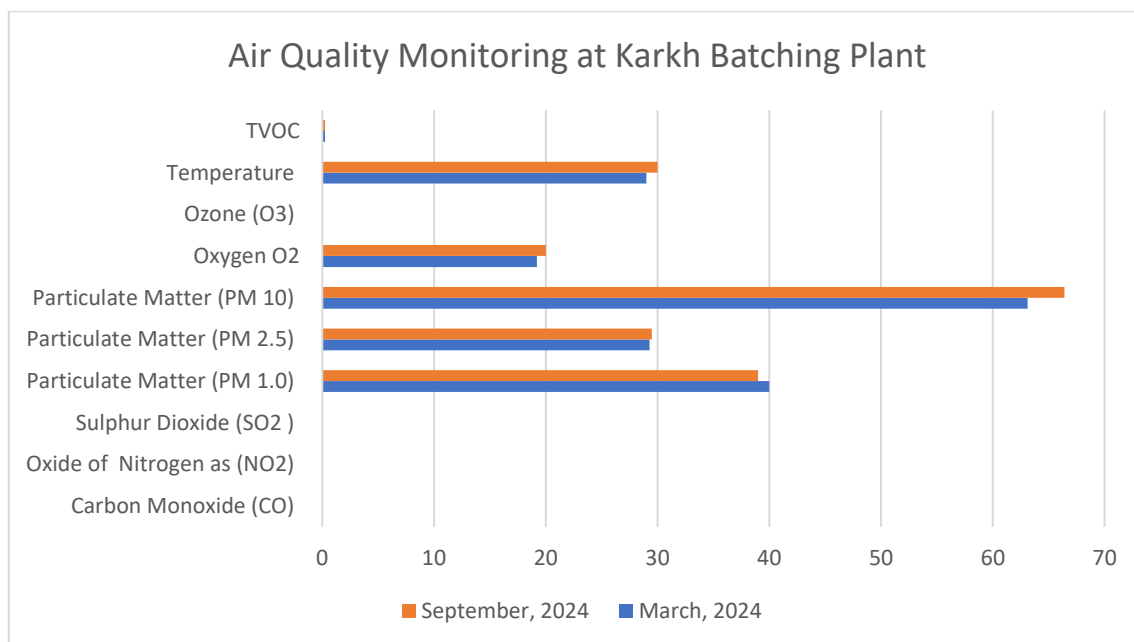
Figure 4-2: Ambient Air Quality at Karkh Batching Plant Site

118. All the results are within the permissible limits and compliance with the BEQS and NEQS. However, it is worth noting that during the first quarter, the contractor has not performed quarterly monitoring at the sub-project sites.
119. Considering the compliance with NEQS there is no immediate need for additional mitigation measures to control dust, apart from the measures proposed in the SSEMP. These measures may include regular sprinkling of water to suppress dust and timely transportation or disposal of excess materials temporarily stored at the site.
120. It is important to regularly monitor and assess the dust levels and compliance with environmental standards throughout the project's implementation to ensure continued adherence to regulations and to address any potential concerns that may arise.

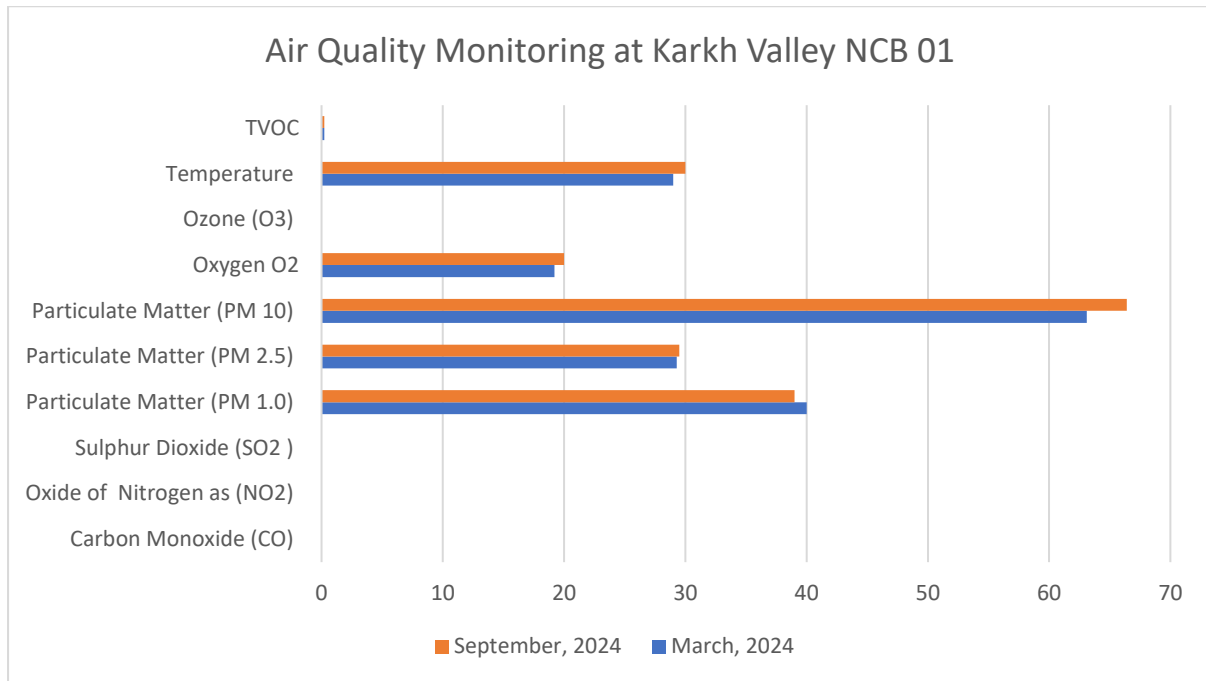
Figure 4-3: Graphical representation of Ambient Air Quality at Karkh Camp site

Sr. No.	Measuring Parameters	Unit	First Quarter	Second Quarter	NEQS Limits	Remarks
1.	Temperature	°C	32	31		
2.	Humidity	%	56	55		
3.	Particulate Matter (PM 1.0)	µg/m ³	41	42	500	WL
4.	Particulate Matter (PM 2.5)	µg/m ³	31.8	30	35 (24 hrs.)	WL
5.	Particulate Matter (PM 10)	µg/m ³	74	73	150 (24 hrs.)	WL
6.	Carbon Monoxide (CO)	mg/m ³	ND	ND	10 (08 hrs.)	WL
7.	Sulphur Dioxide (SO ₂)	µg/m ³	ND	ND	120 (24 hrs.)	WL
8.	Oxide of Nitrogen as (NO ₂)	µg/m ³	ND	ND	80 (24 hrs.)	WL
9.	Oxygen O ₂	%	19.2	20	-	
10.	Formaldehyde	µg/m ³	0.169	0.167	-	
11.	Total Volatile Organic Compounds (TVOC)	µg/m ³	0.233	0.239	-	
12.	Ozone (O ₃)	µg/m ³	ND	ND	130 (01 hr.)	WL

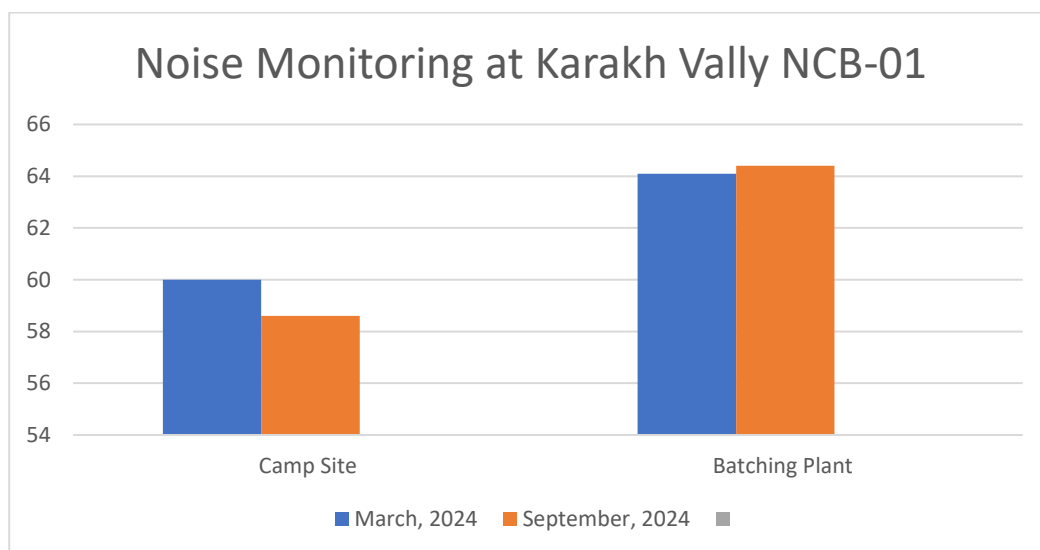
Figure 4-4: Graphical representation of Noise Monitoring at Karakh Vally NCB-01

122. The comparison of noise level monitoring results obtained during the instrumental monitoring are shown in Table 4-9 below.

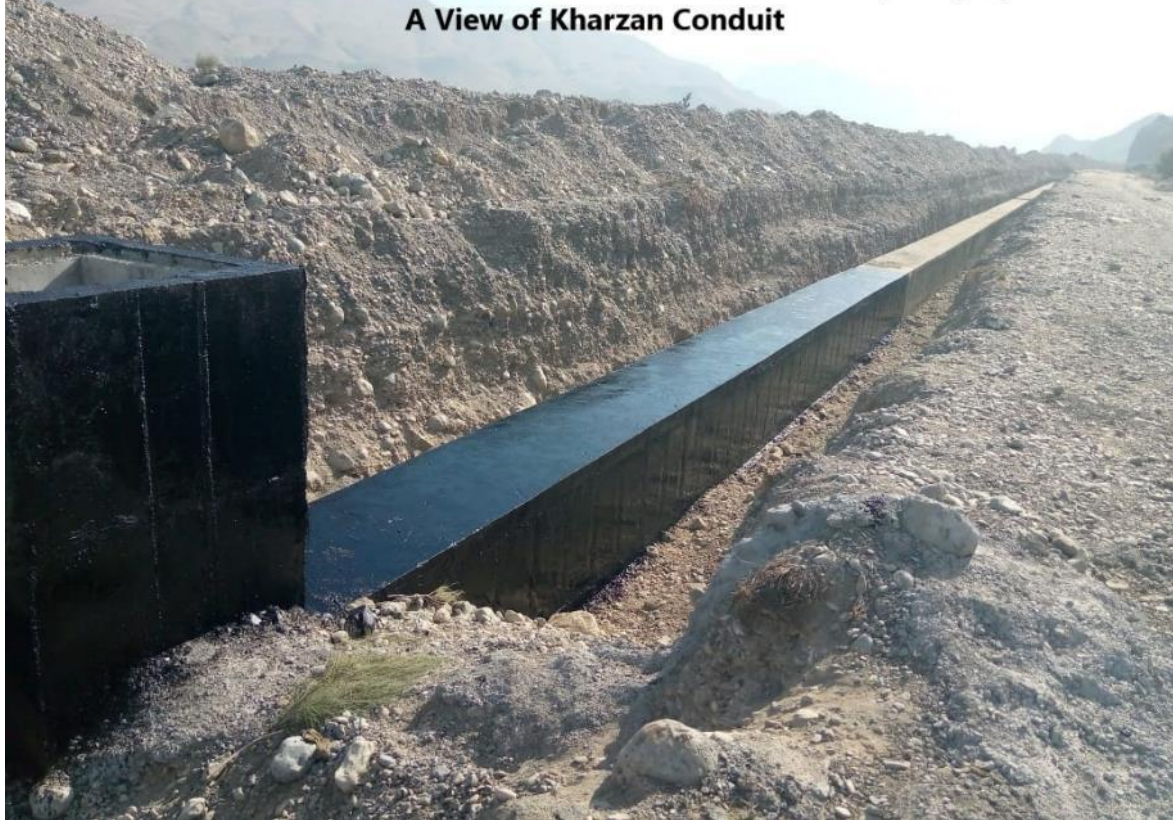
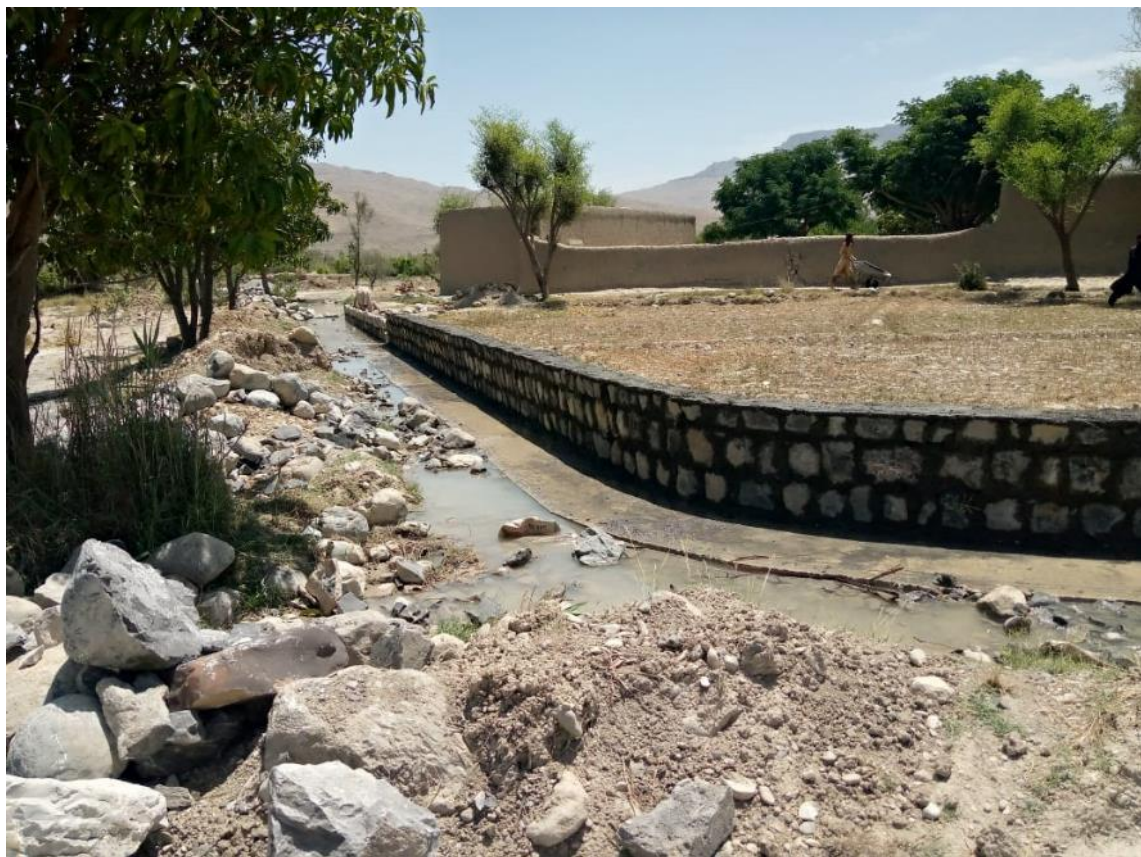
**NCB-02 - Construction of Kharzan Hatachi Infiltration Gallery subproject - MRB
A View of Kharzan Conduit**

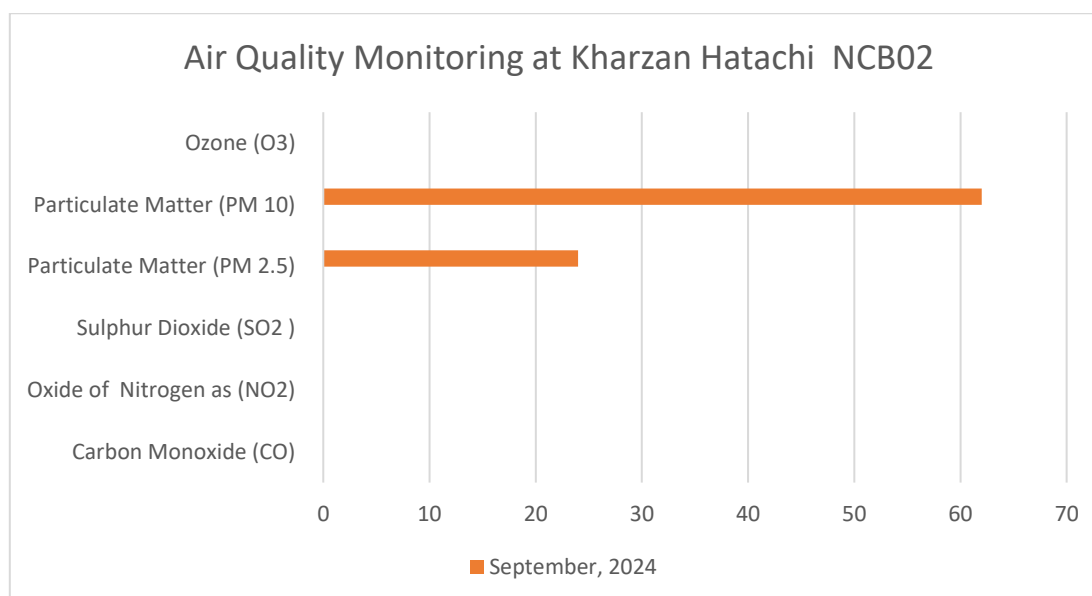
Figure 5-2: Ambient Air Quality Kharzan Hatachi NCB 02

161. Ambient air quality (temperature, humidity, PM1.0, PM2.5, PM10, CO, SO2, NO2, O2, formaldehyde, Total Volatile Organic Compounds (TVOC), O3) were monitored for twenty-four (24) hours at the locations identified by the SC and results obtained are shown in Figure 5-2. Signed copies of the results are attached as **Annexure-XIII**.

All the results are within the permissible limits and compliant with the BEQS, NEQS. PM10 and PM2.5 levels exceeded stringent WHO standards, primarily due to high vehicle movement and dust accumulation near the monitoring points. However, it is worth noting that during the first quarter, the contractor did not perform quarterly monitoring at the sub-project sites.

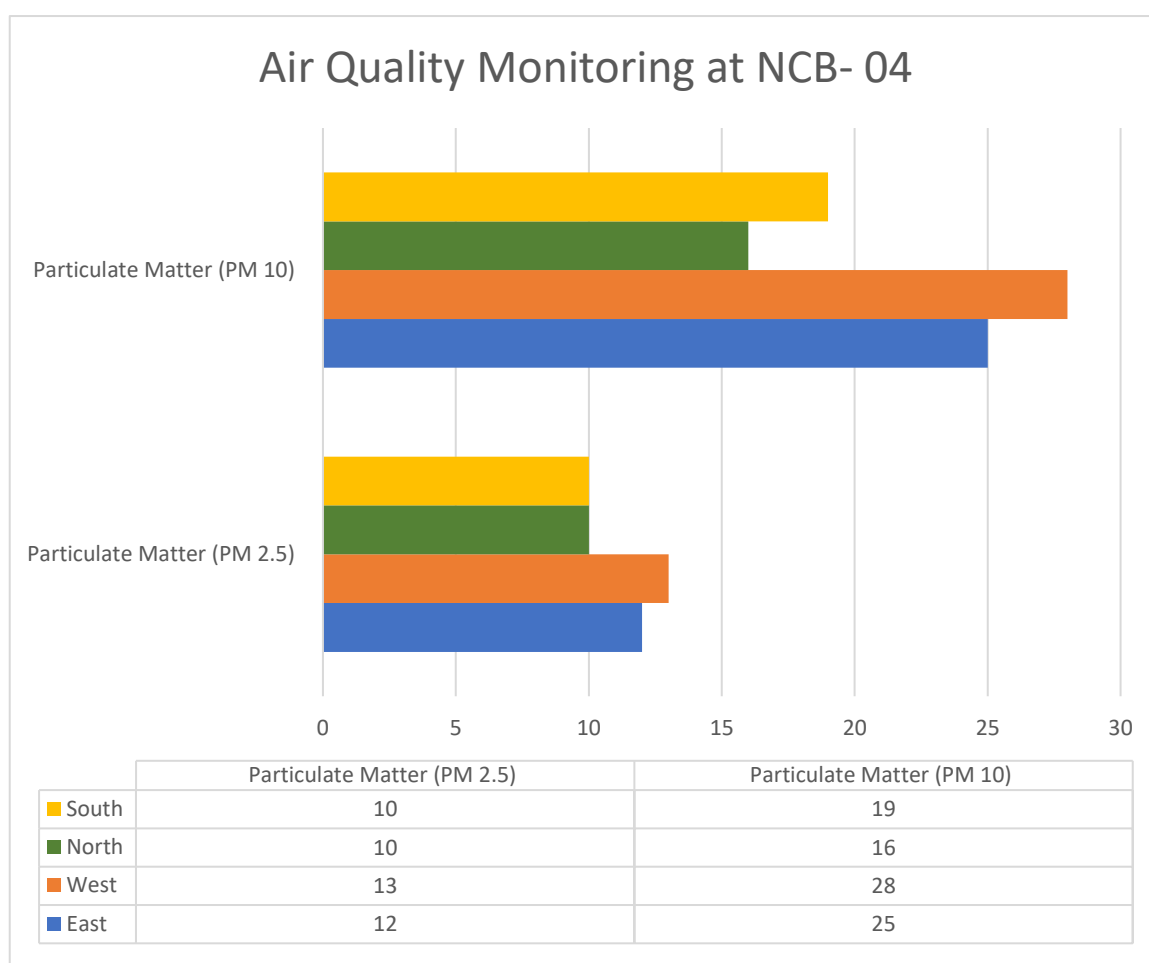
Figure 6-3: Graphical representation of Ambient Air Quality at NCB-04

202. Ambient air quality (NO, NO₂, SO₂, CO, O₃, SPM, PM₁₀, PM_{2.5}, Humidity, Wind direction, Wind velocity, Pressure etc) were monitored for twenty-four (24) hours at the locations identified by the SC and results obtained are as under.

The contractor has performed quarterly monitoring at the sub-project sites and all the results are within the permissible limits and compliance with the BEQS, NEQS and WHO standards. are shown as in Figure 6-3 and Table 6-6. Signed copies of the results are attached as **Annexure-XIV**.

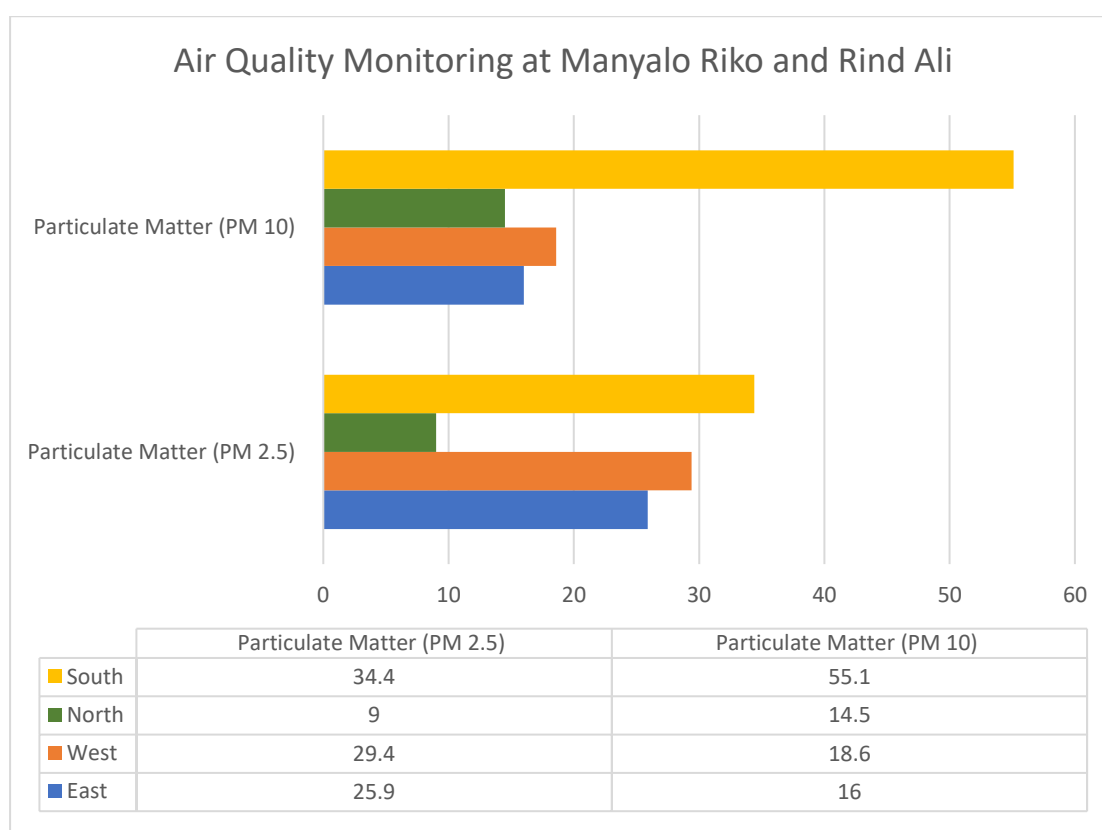
Figure 7-2: Graphical representation of Ambient Air Quality at NCB-07

254. Ambient air quality (NO, NO₂, SO₂, CO, O₃, SPM, PM₁₀, PM_{2.5}, Humidity, Wind direction, Wind velocity, Pressure etc) were monitored for twenty-four (24) hours at the locations identified by the SC and results obtained are shown as Annexure XV.

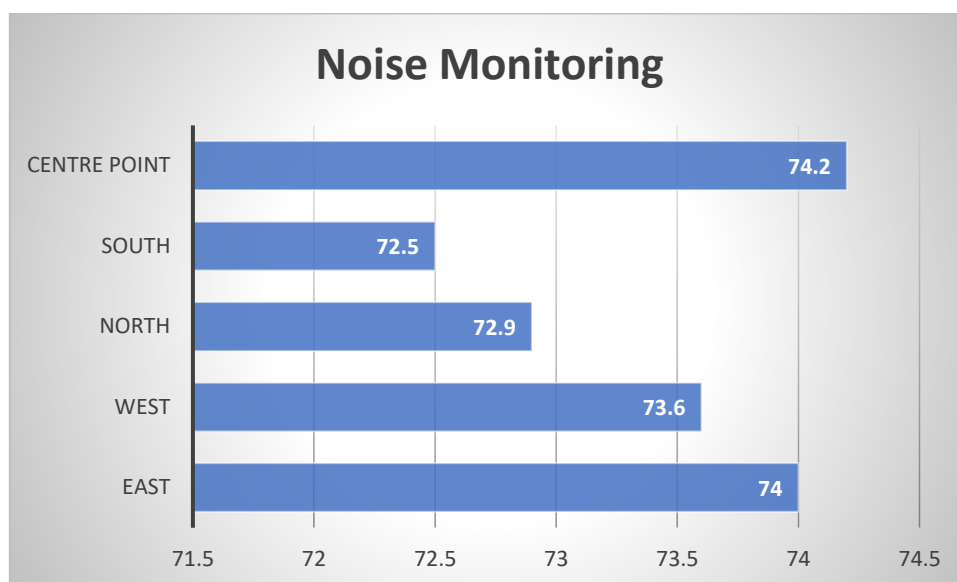
Figure 7-3: Graphical Representation of Noise Monitoring

259. Following table 7-8 shows comparison of noise level monitoring results obtained during the instrumental monitoring.

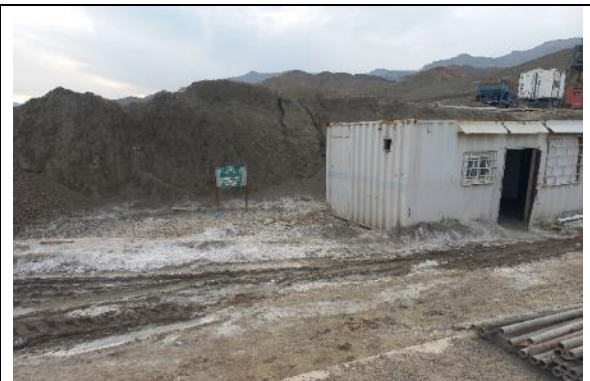
Lack of housekeeping on the dam site area, and the ground is observed uneven

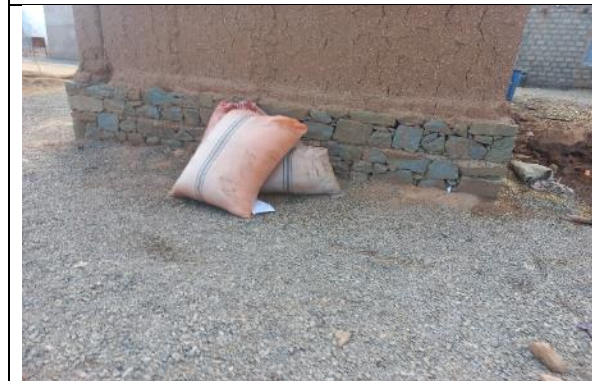
Unwanted items observed on Assembly point of the Camp area

5.	Unwanted items were observed at the Assembly Point in the camp area, and waste was not properly disposed of	Ensure proper disposal of waste at designated areas and keep the assembly point clean	Contractor	CSC	5 January 2025	Open

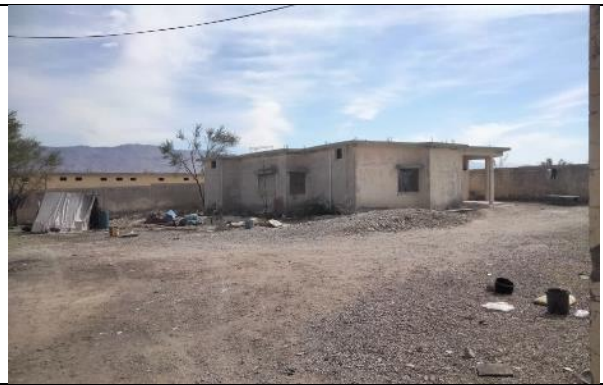
Poor Hygiene condition at Camp

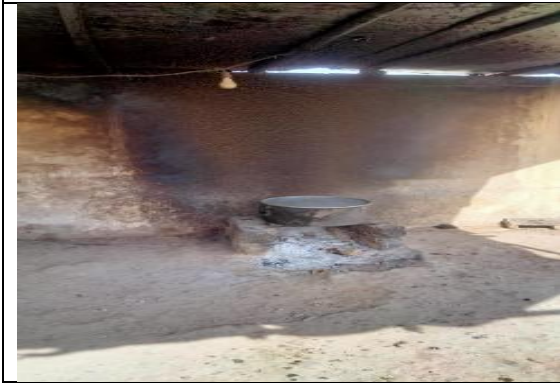
Use of wood for cooking

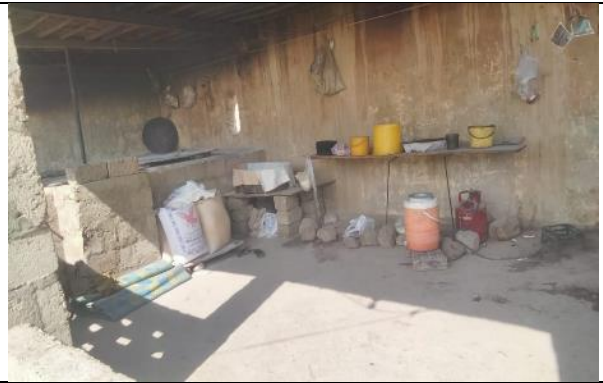
Poor Hygiene condition in Kitchen

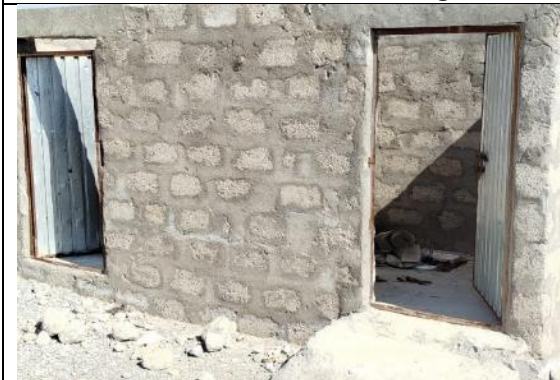
No cleaning of washrooms at site

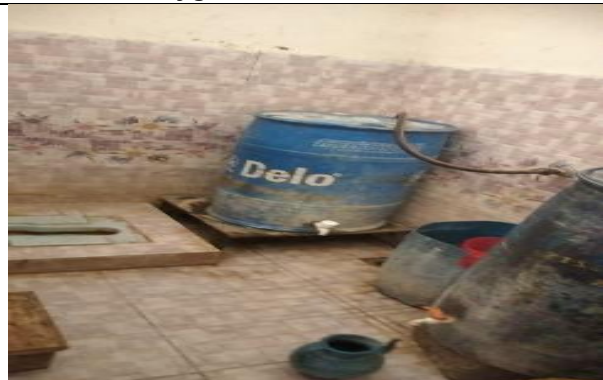
Poor Hygiene condition in washroom at Camp

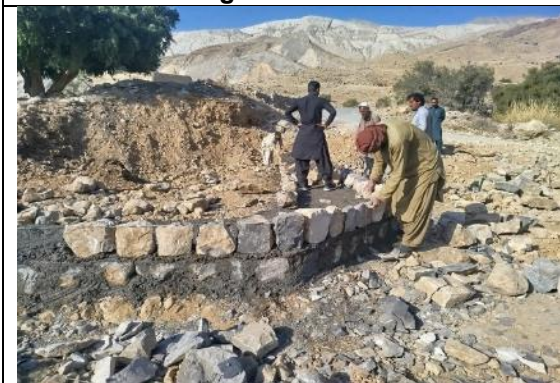
No PPEs Compliance
