Environmental Monitoring Report

6 Semestral Report
July 2024

Pakistan: Balochistan Water Resources Development Sector Project

Prepared by Balochistan Irrigation Department and the Agriculture and Cooperatives Department
for the Islamic Republic of Pakistan and the Asian Development Bank (ADB).

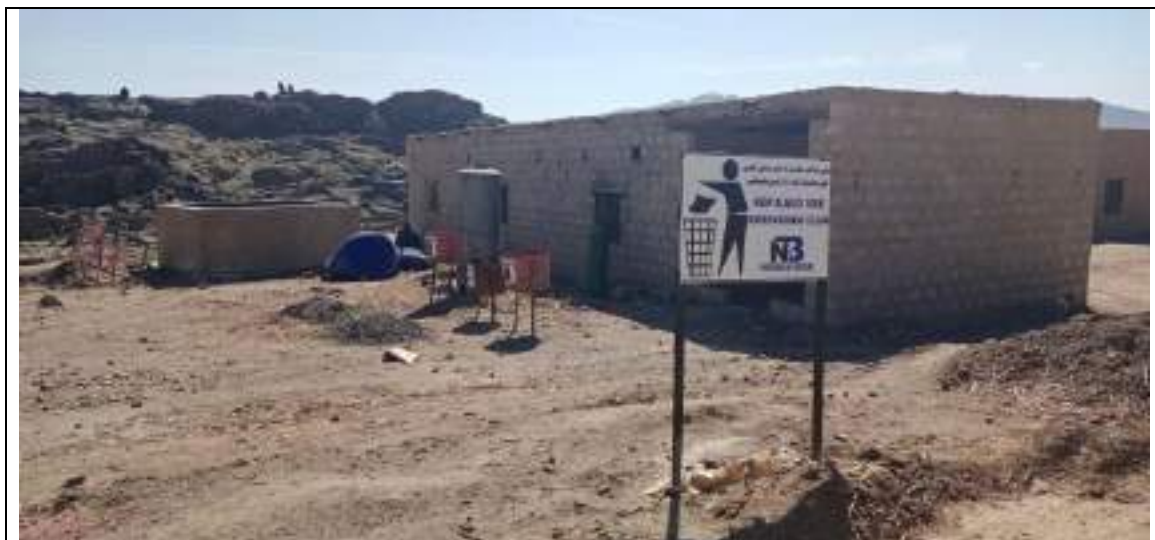
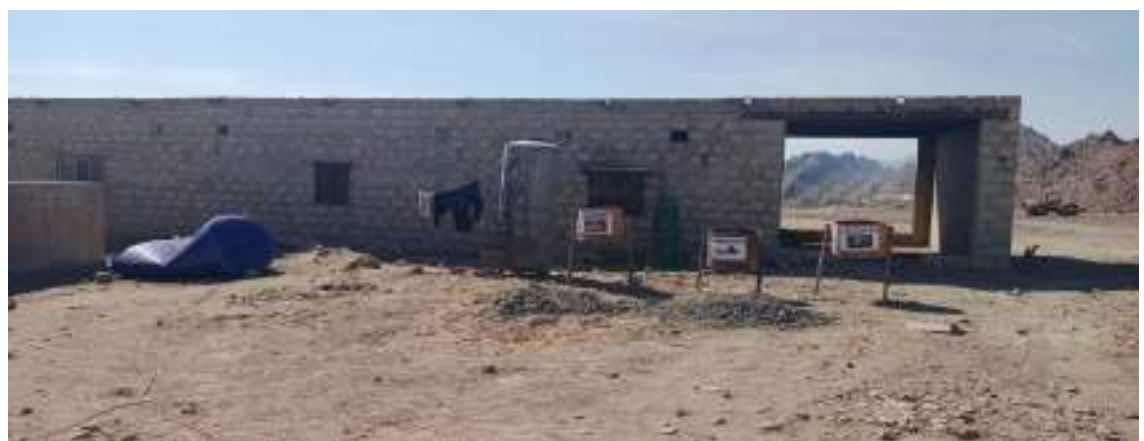
Figure 10: Signage and waste segregation

Inspection of waste bins in Siri Toi Dam Camp site

Presence of signboards for adequate disposal of waste at Camp site

81. As discussed in the previous section, small quantities of waste, including plastics, cloth pieces, and cartons, have been observed at a few locations due to a windstorm. Such waste can be managed through the provision of improved waste storage areas designated in the campsite.

82. At the waste collection area of the camp, wastes of economic value are segregated and sold to recyclers, while the remaining waste, mostly degradable in nature, is then dumped in a pit near the camp with the approval of the Project Consultant.

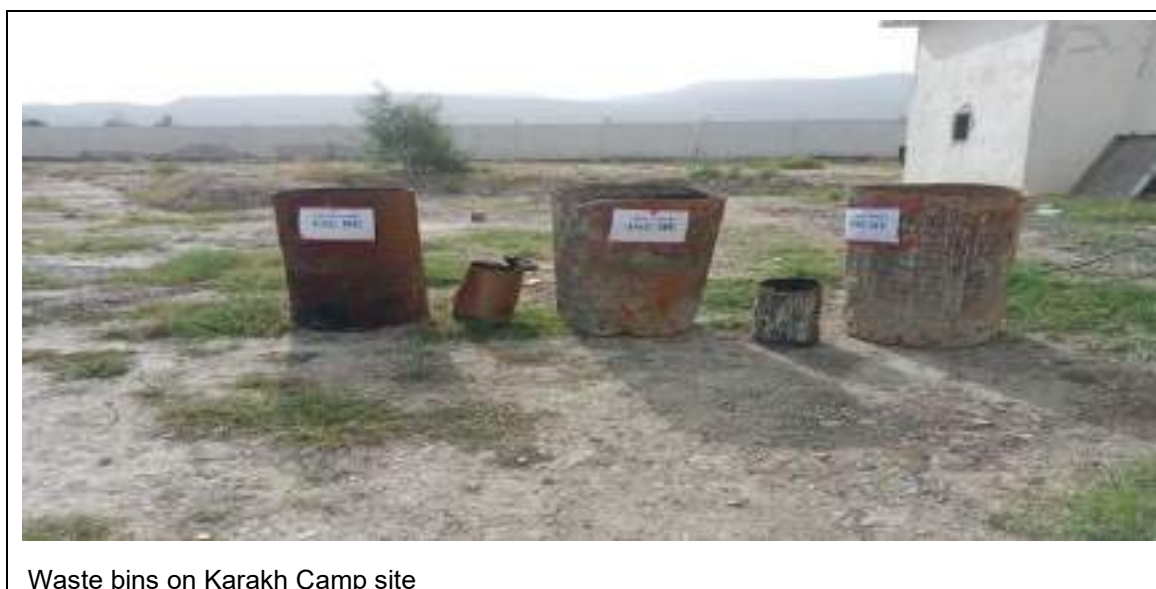
Figure 11: Waste Segregation at Camp site

Waste bins on Karakh Camp site

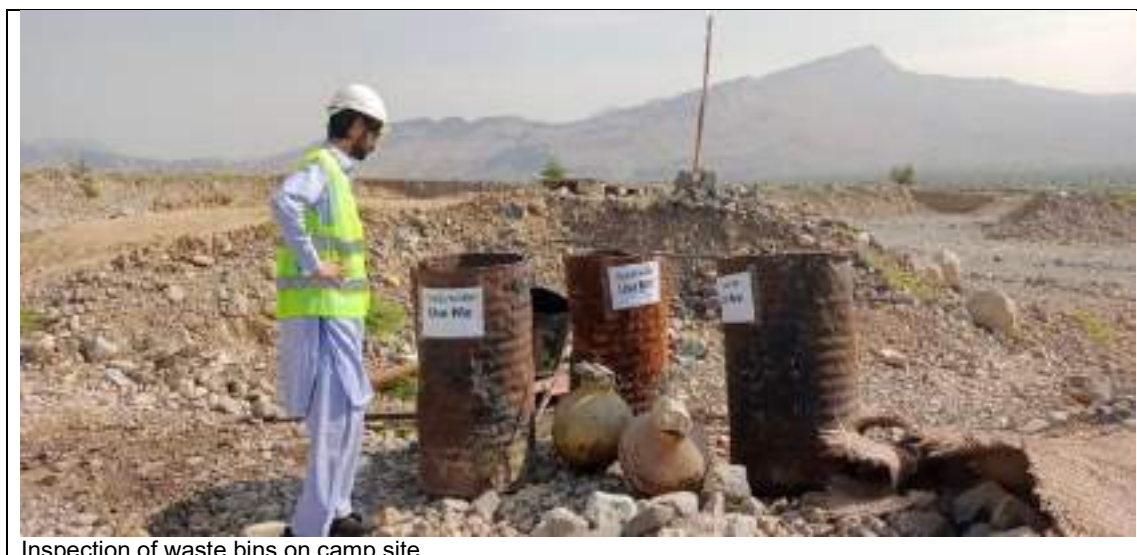
Figure 12: Waste Segregation at camps

Inspection of waste bins on camp site.

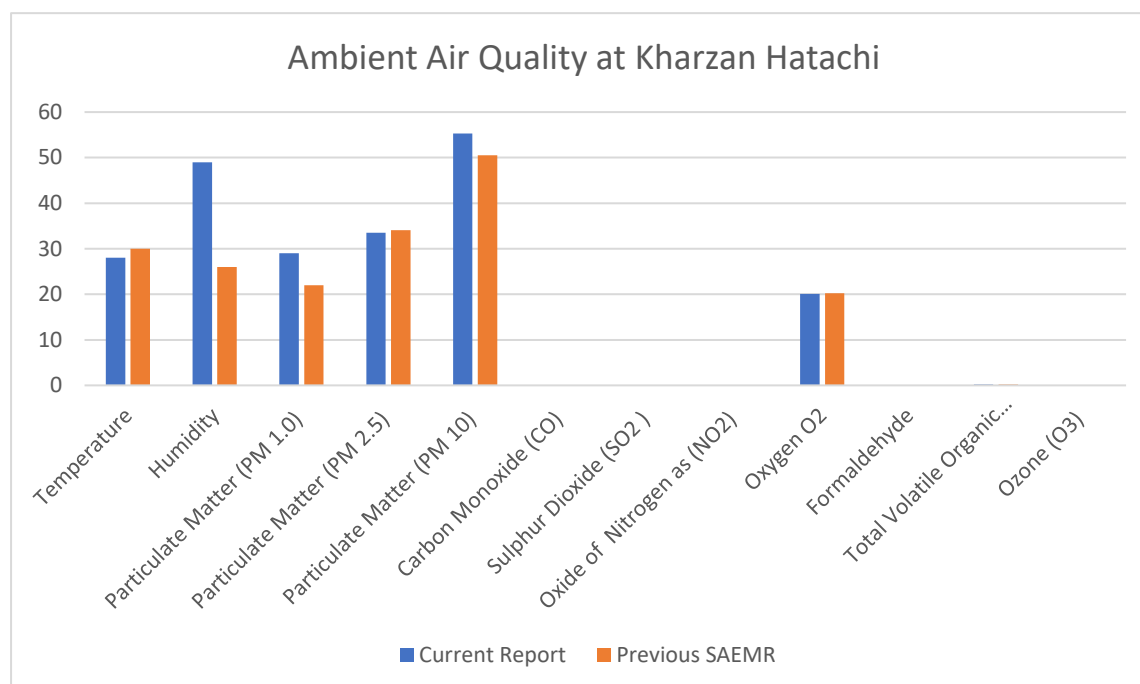
Figure 17: Ambient Air Quality at Kharzan Hatachi

147. All the results are within the permissible limits and in compliance with the NEQS. However, it is worth noting that during the first quarter, the contractor did not perform quarterly monitoring at the sub-project sites.

148. Considering the compliance with NEQS there is no immediate need for additional mitigation measures to control dust, apart from the measures proposed in the SSEMP. These measures may include regular sprinkling of water to suppress dust and timely transportation or disposal of excess materials temporarily stored at the site.

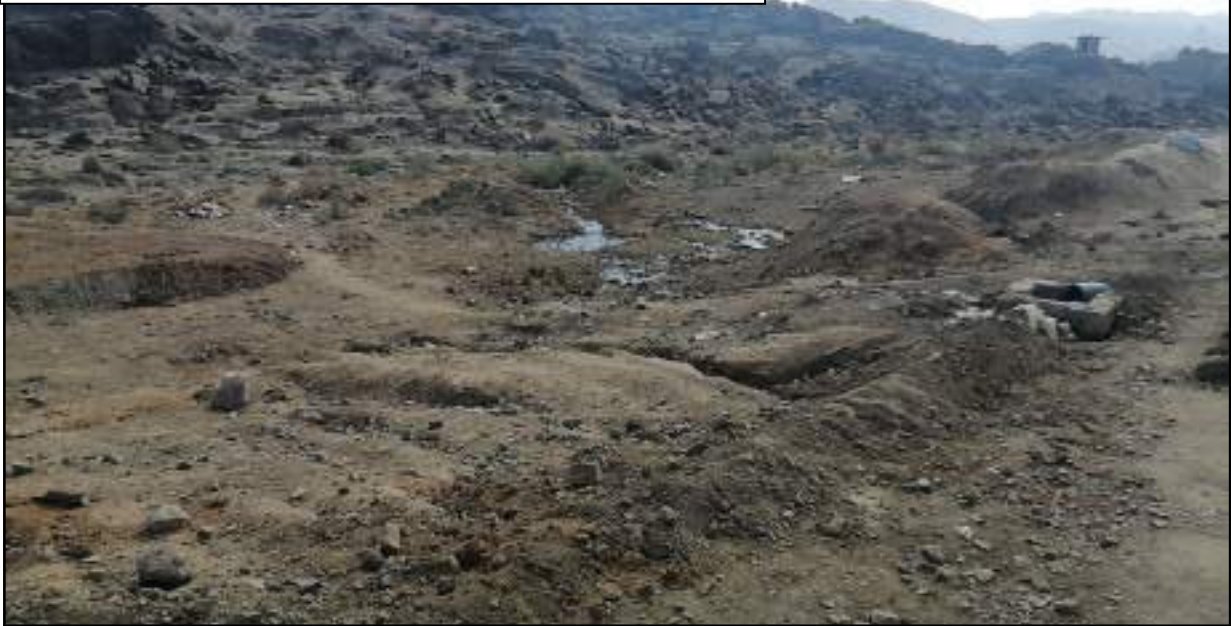
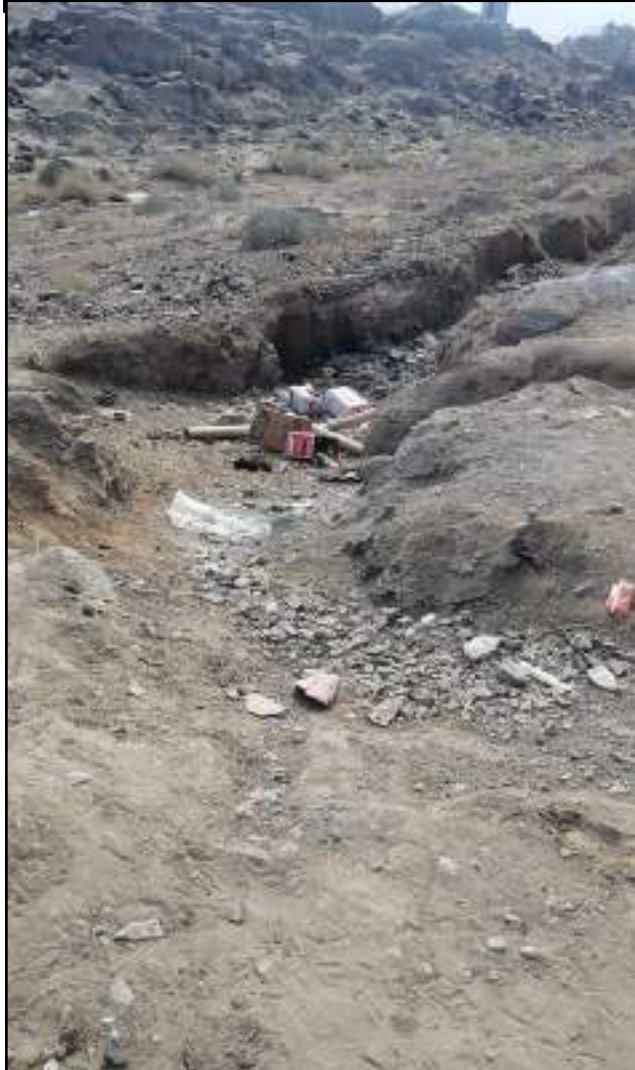
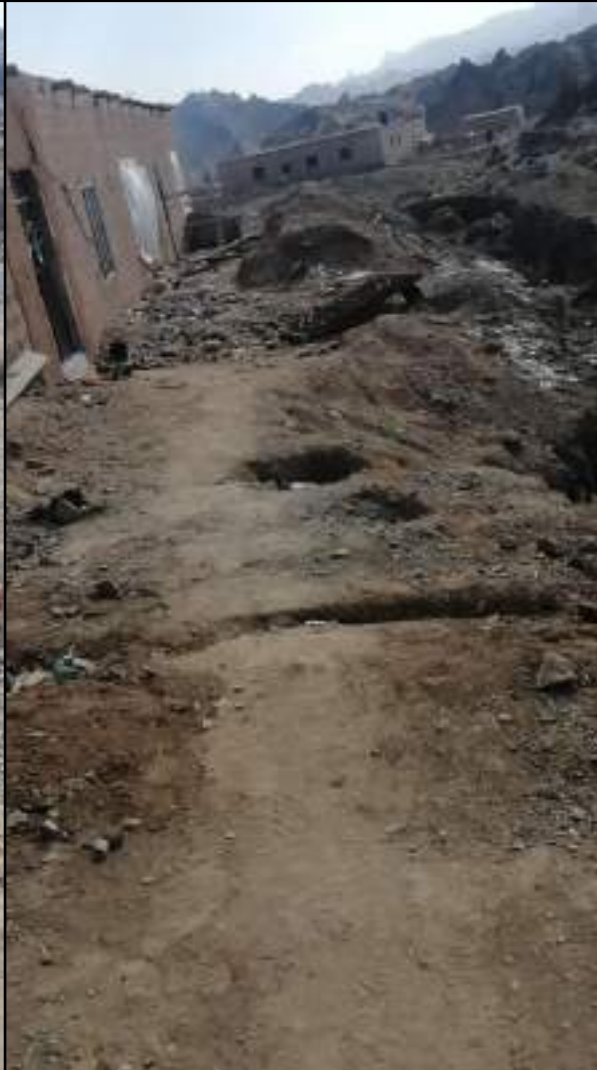
Solid waste and open pits
