Environmental Monitoring Report

3 Semestral Report
November 2023

Pakistan: Balochistan Water Resources Development Sector Project

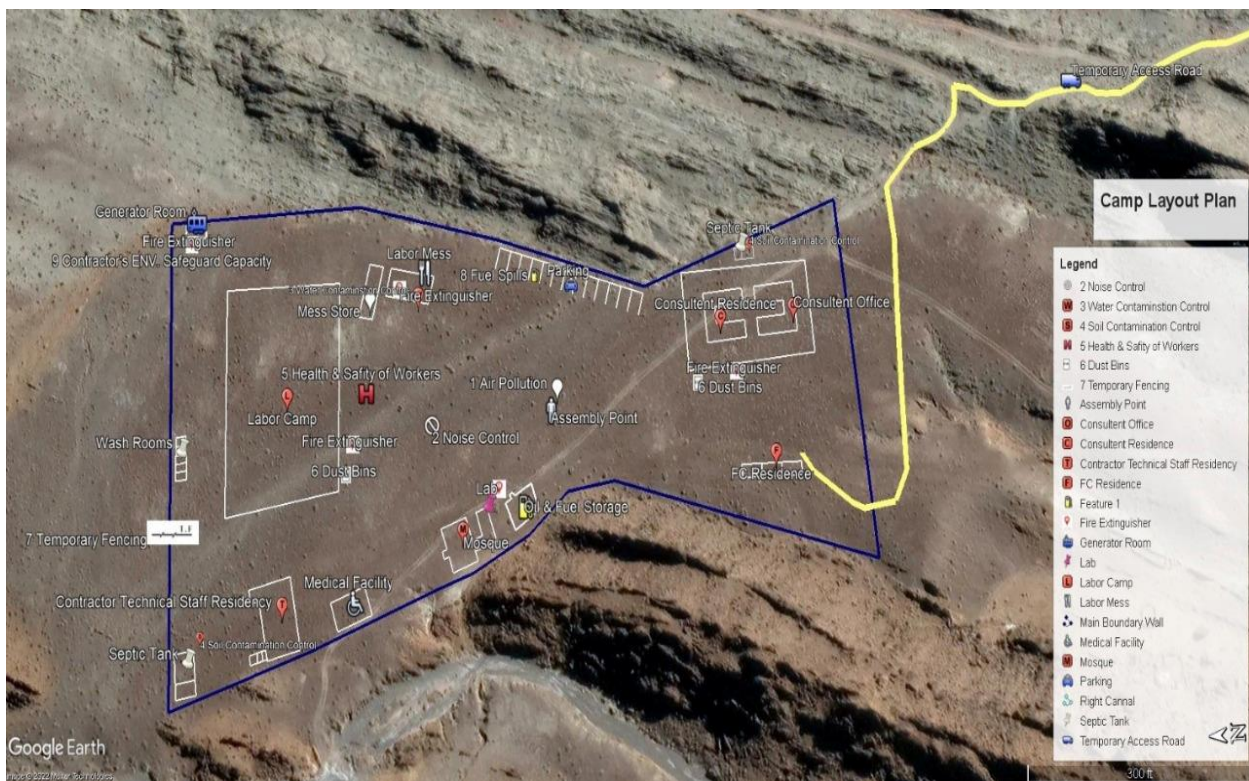
Figure 3-1 Camp Site Location

28. The location of Sri Toi Dam camp is far away from the local community/settlement. The total area of the leased land is 20 Acres (Est.). Construction camp consists of consultant and contractor offices, consultant and contractor staff residency, labor accommodation, mess for staff and labor, residency of FC, Masjid. Contractor staff. Camp include worksite facilities that can house between 150 and 200 workers, with an average permanent staffing and workers on site.

32. Waste disposal site has been established to cater the waste from labour camp and site office.

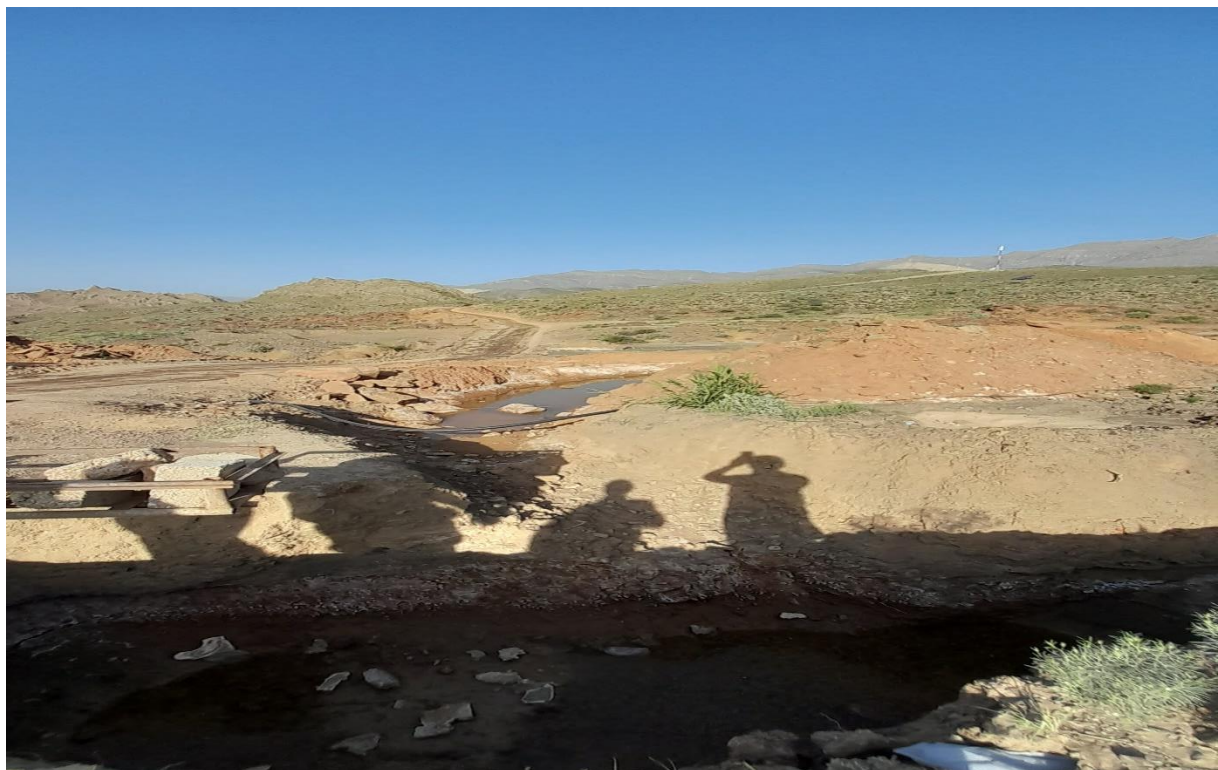
69. Flora and Fauna are not unnecessarily damaged.
70. Establishment of Contractor's camp is within the permissible standards and Parameters.
71. Some of the observations were related to proper disposal of medical waste and open drainage of waste water within the camp area. The staff was guided to carry out best practices pertaining to these issues.

Open drainage of water in the camp area

85. Regular training and site visits by Contractor and Consultant Environment Specialist at the regular basis are also required.
86. The important Non-Compliance Issues identified are Proper disposal of Medical Waste, Proper Drainage of Waste Water, Generator placement and protection.

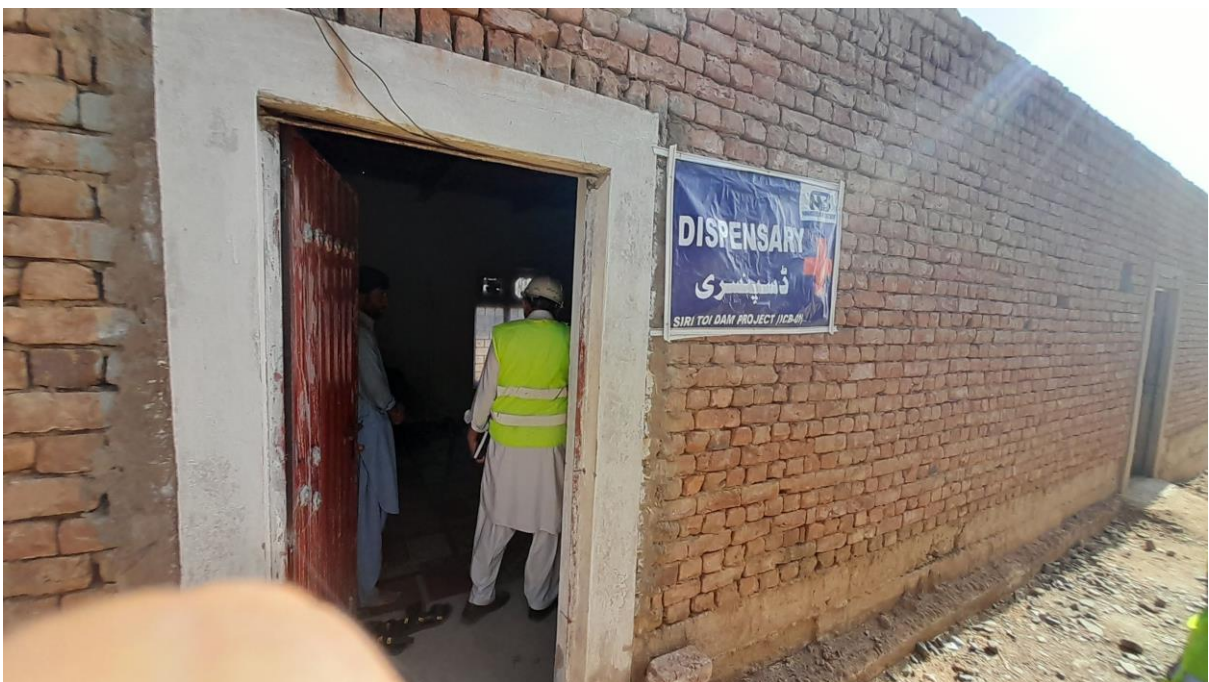
- A material testing laboratory has been constructed inside the camp.
- A dispensary has been provided near the offices, which has facilities with para medical staff along with some emergency medicines. A full-time ambulance facility is provided for any serious emergencies.

Dispensary set-up within the camp

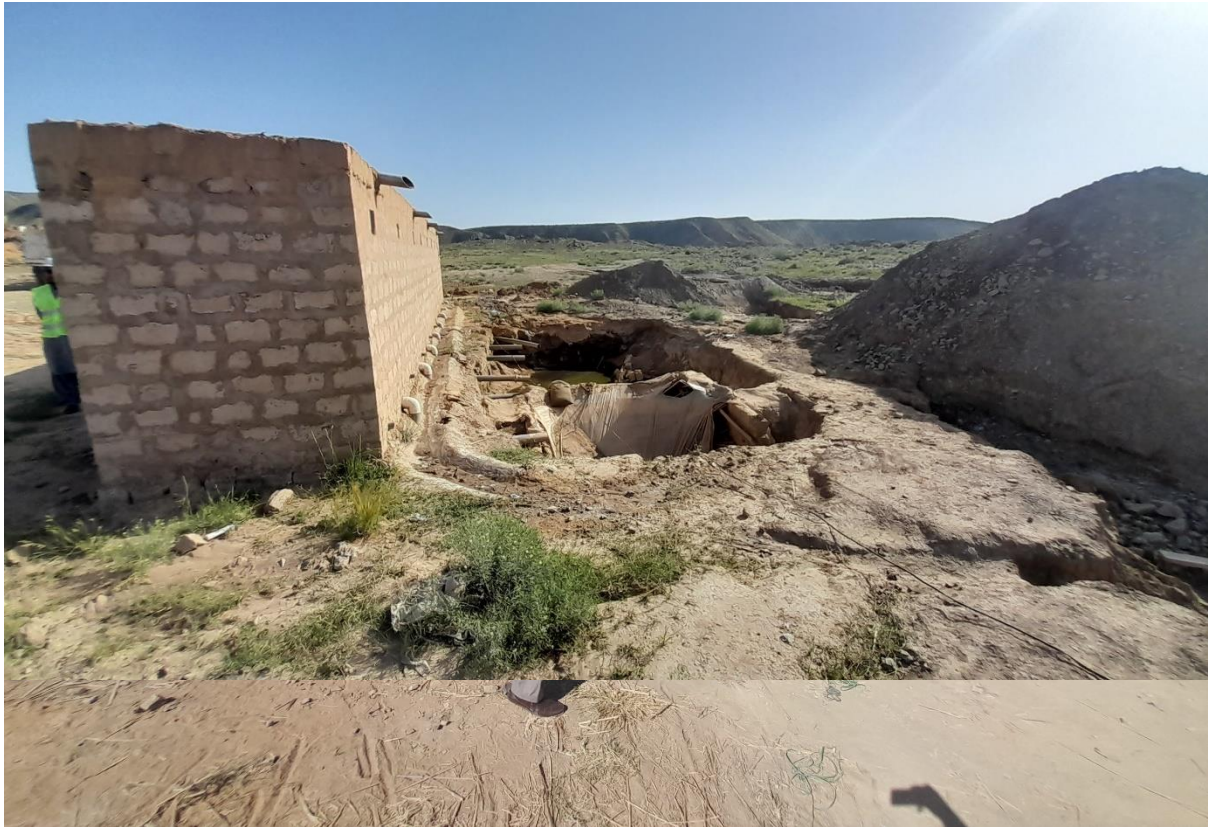
Open pit behind toilets

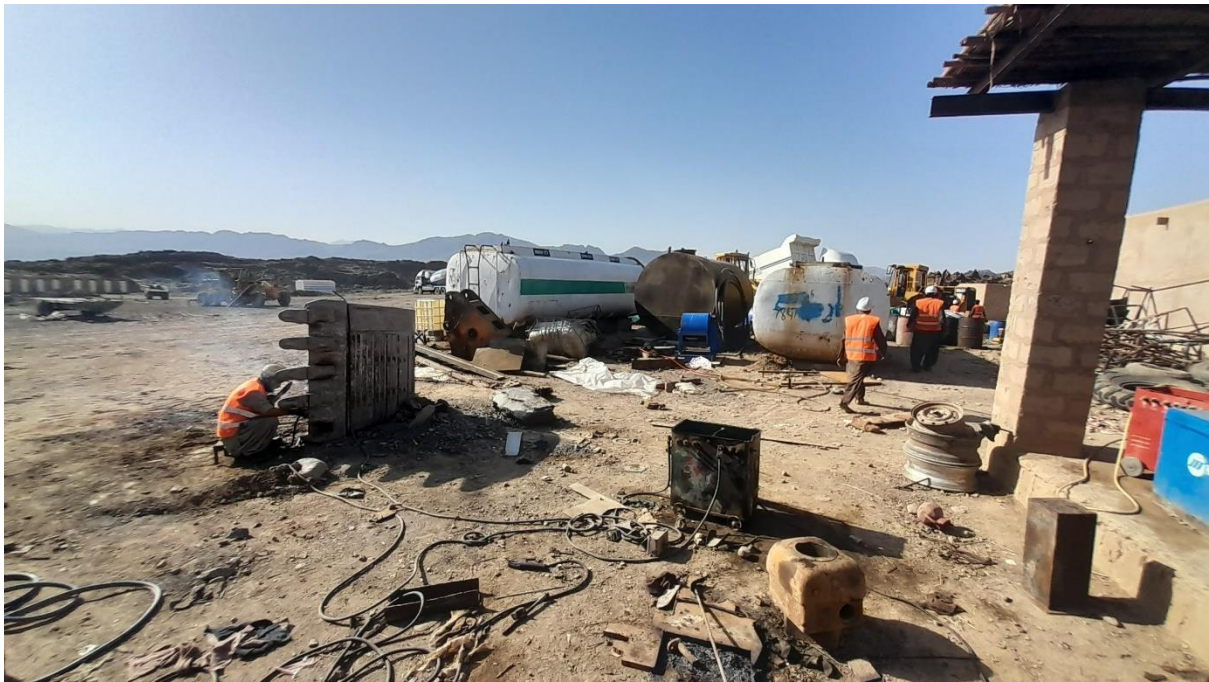
Hot work in progress

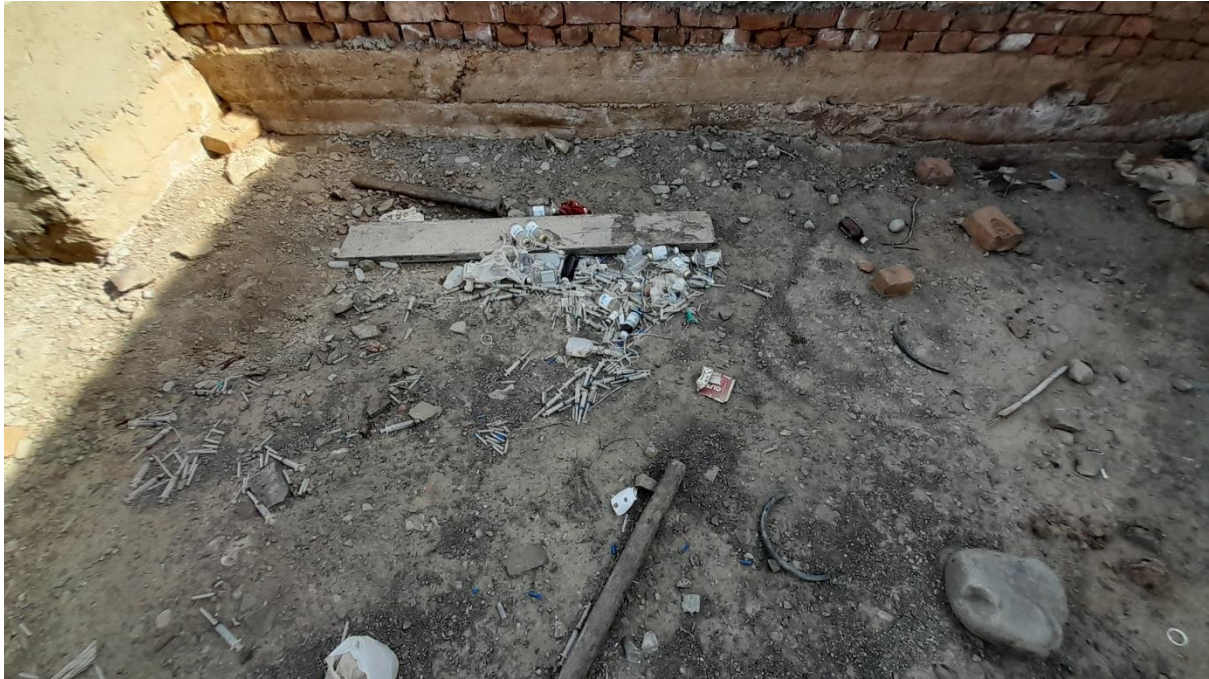
52. It was observed by the monitoring consultant that the medical waste was not being dumped properly. The contractor`s staff was guided regarding disposal of this waste in appropriate manner.

Medical Waste behind dispensary

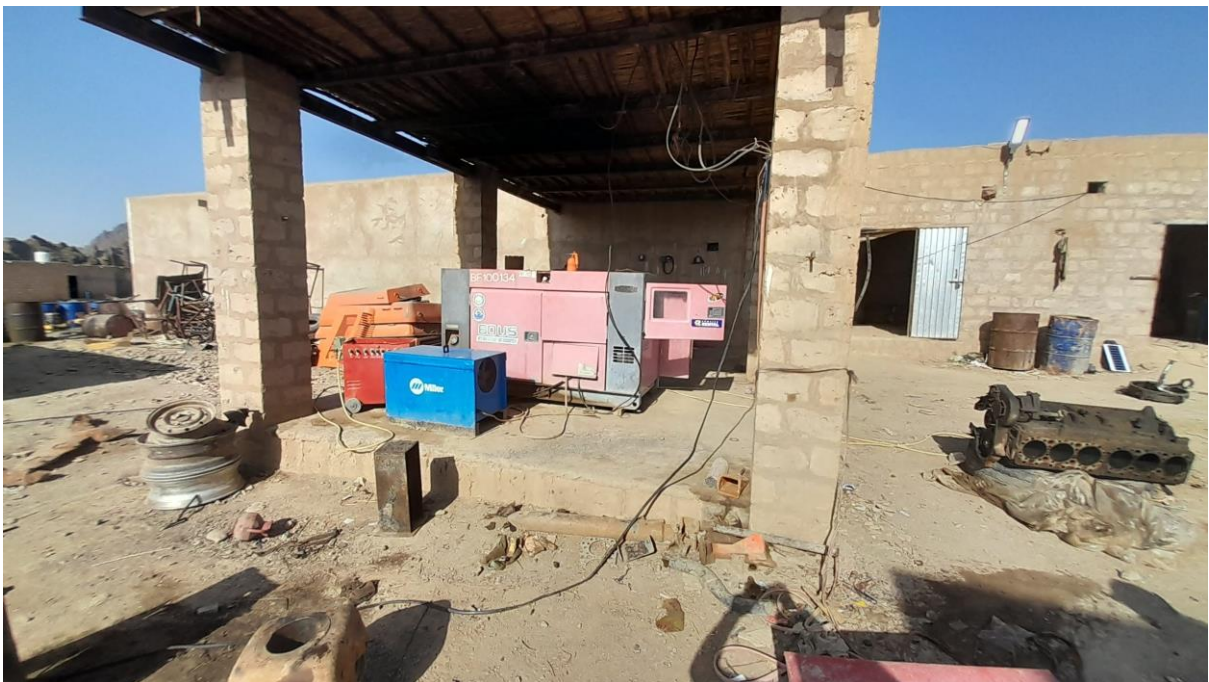
48. The safety signs and signage have been arranged properly by the contractors to warn people, especially about the high intensity or level of noise being generated by the machinery. During consultant team visits contractors were assisted to re-install signboards inside and outside the camp site. The Generator to be properly covered and to be placed it at a distance from residence/office.

Generator setup without barricading
