Environmental Monitoring Report

Pakistan: Balochistan Water Resources Development Sector Project

5th Semi – Annual Environmental Monitoring Report (External/Third party)

January – June, 2024

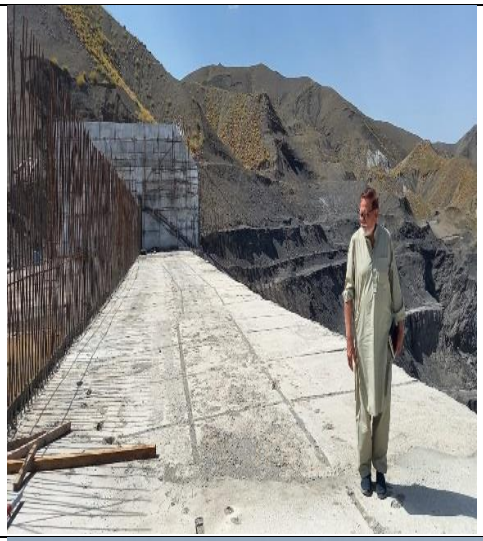
Dam construction area

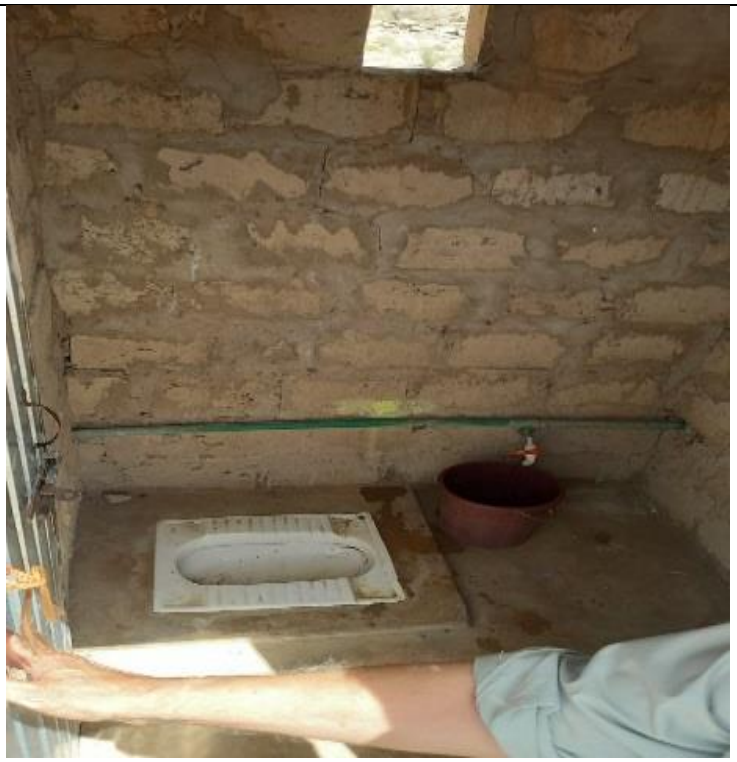
Labor residence, mess, kitchen, drinking water filter, washrooms

37. The construction camp has the accessibility to safe drinking water, as per water analyzing results.
38. The Sanitary and toilet facilities, washing facilities, Kitchen/mess exists but not proper facilitation and Hygienic conditions for the labor camps.
